# Asbestos Inspections Australia Pty Ltd

## Asbestos Inspection Report

Property: Property name deleted  
Property address deleted

Date of Inspection: 6 August 2008

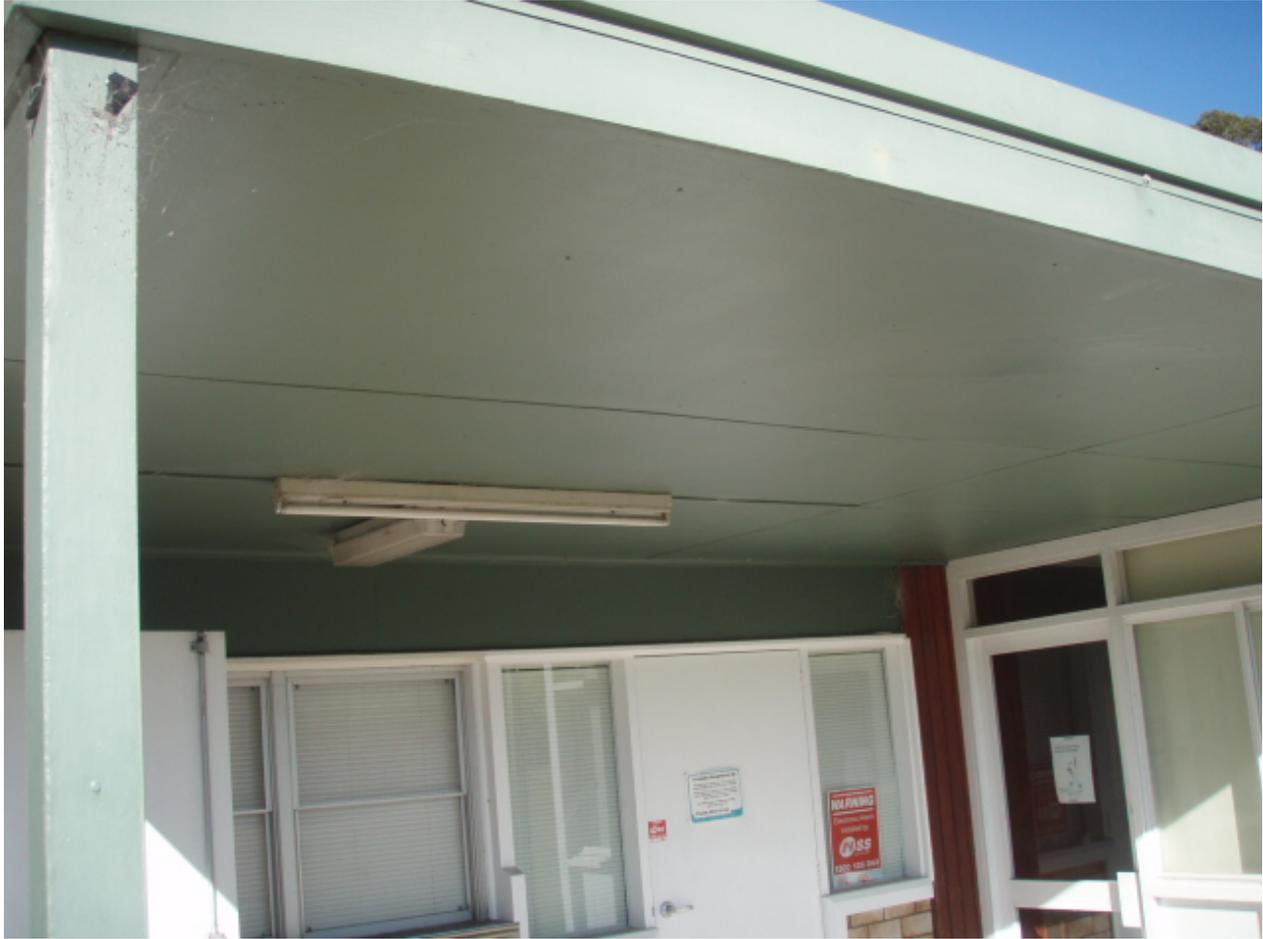
Photo 1

Fibre cement ceiling to the front external entryway to the hall.

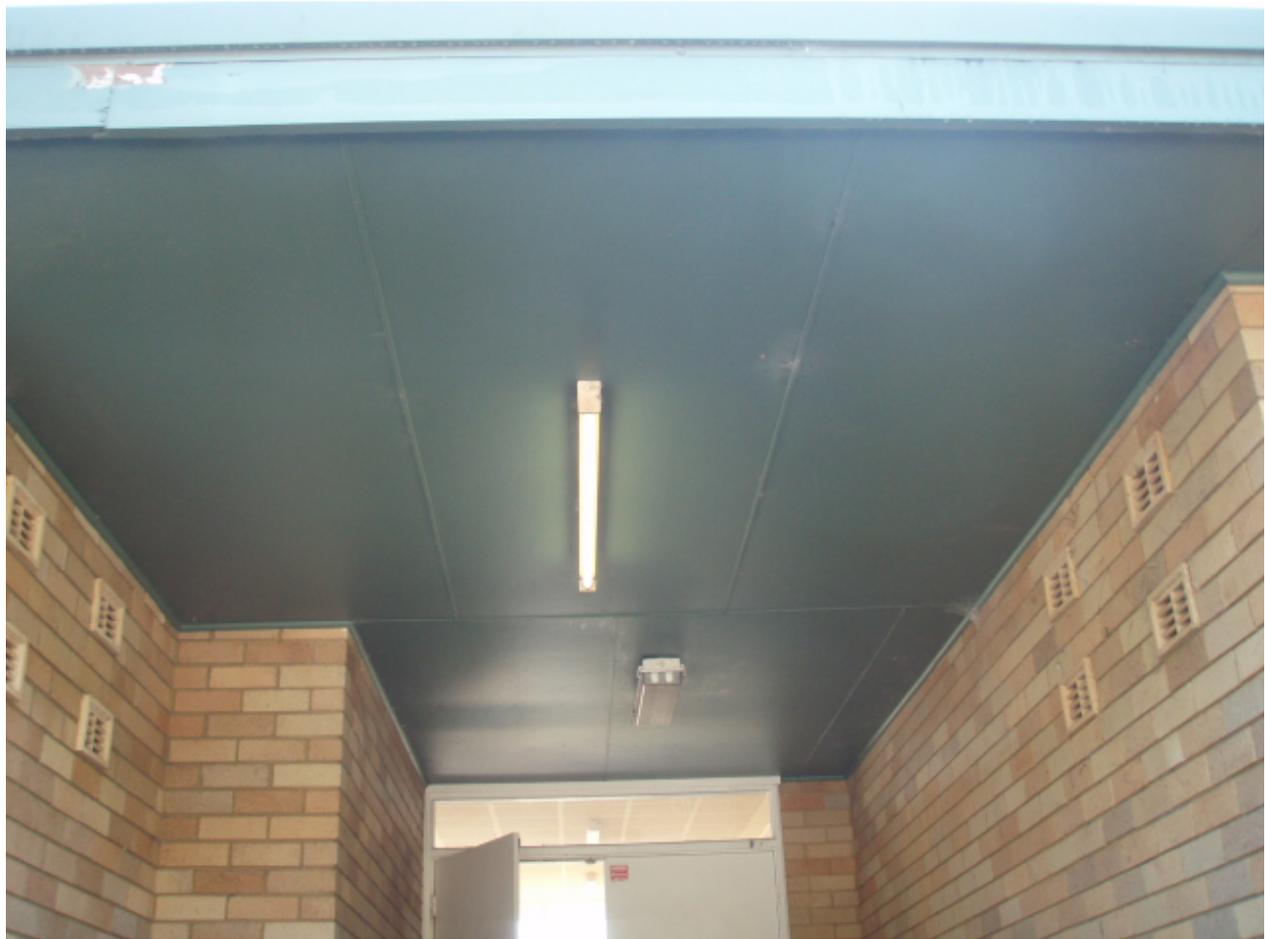
Photo 2

Fibre cement ceiling to the rear external entryway to the hall.

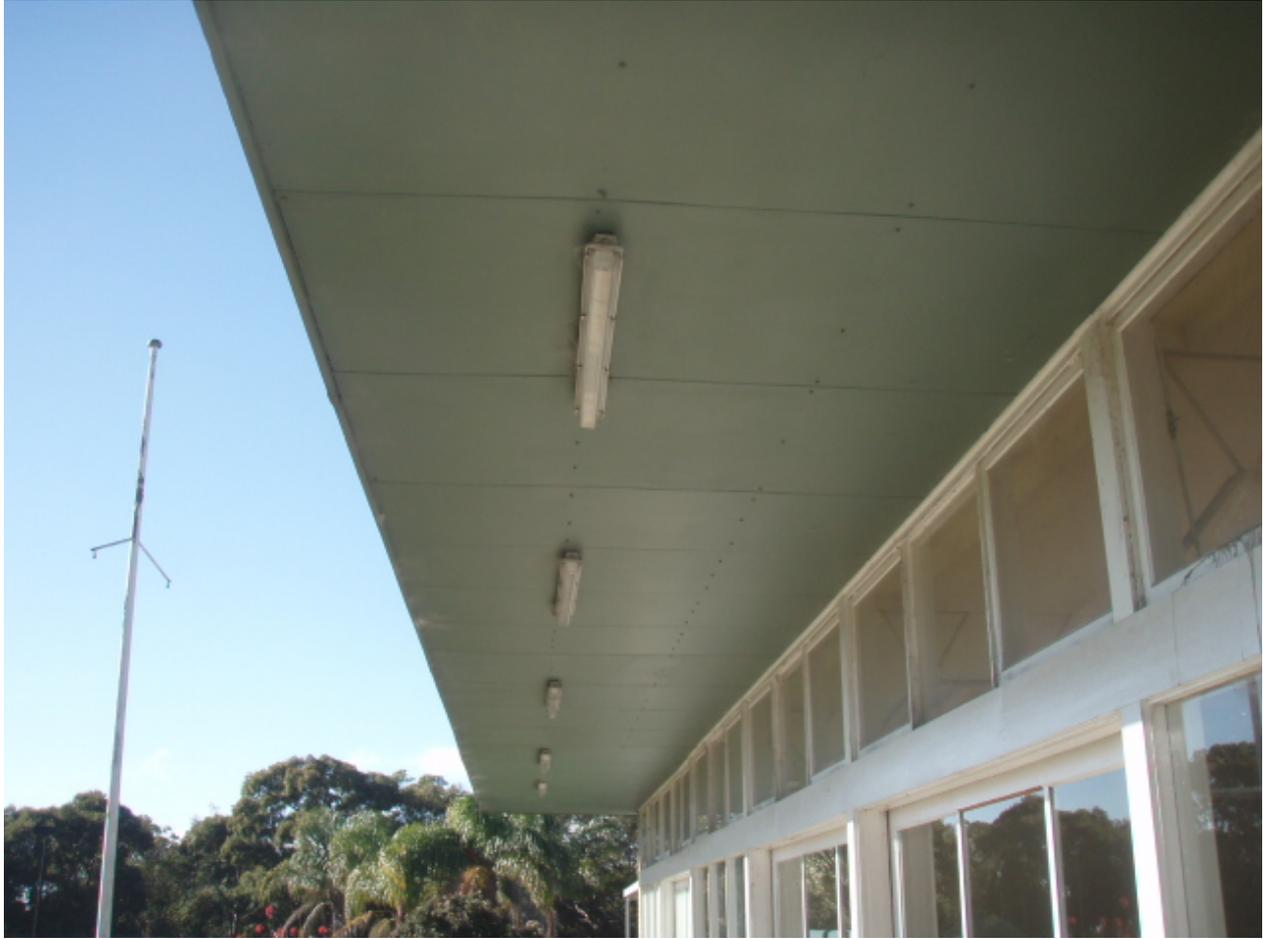
Photo 4

Fibre cement eaves round the roof to the building.

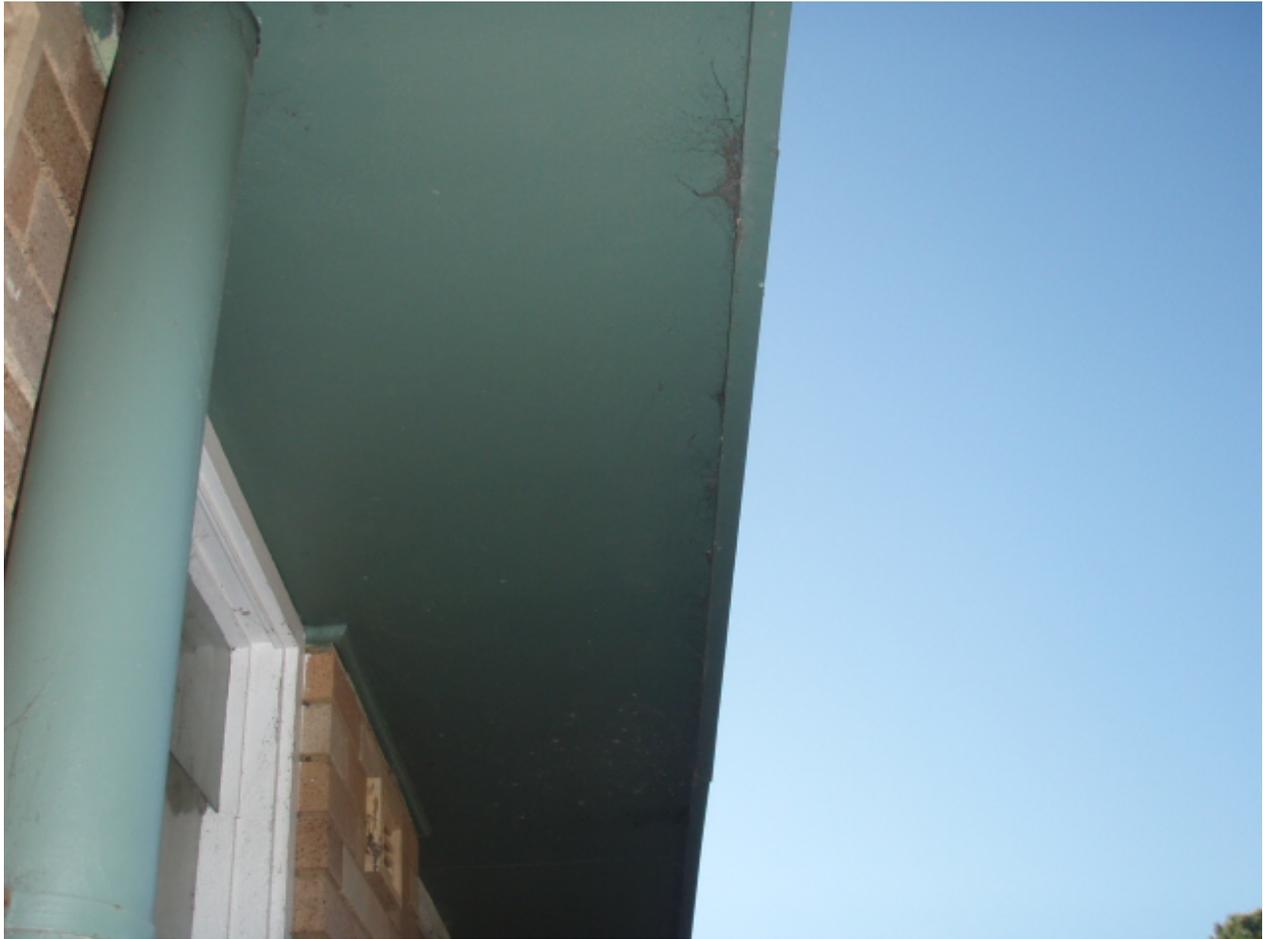
Photo 5

Fibre cement eaves around the roof to the building.

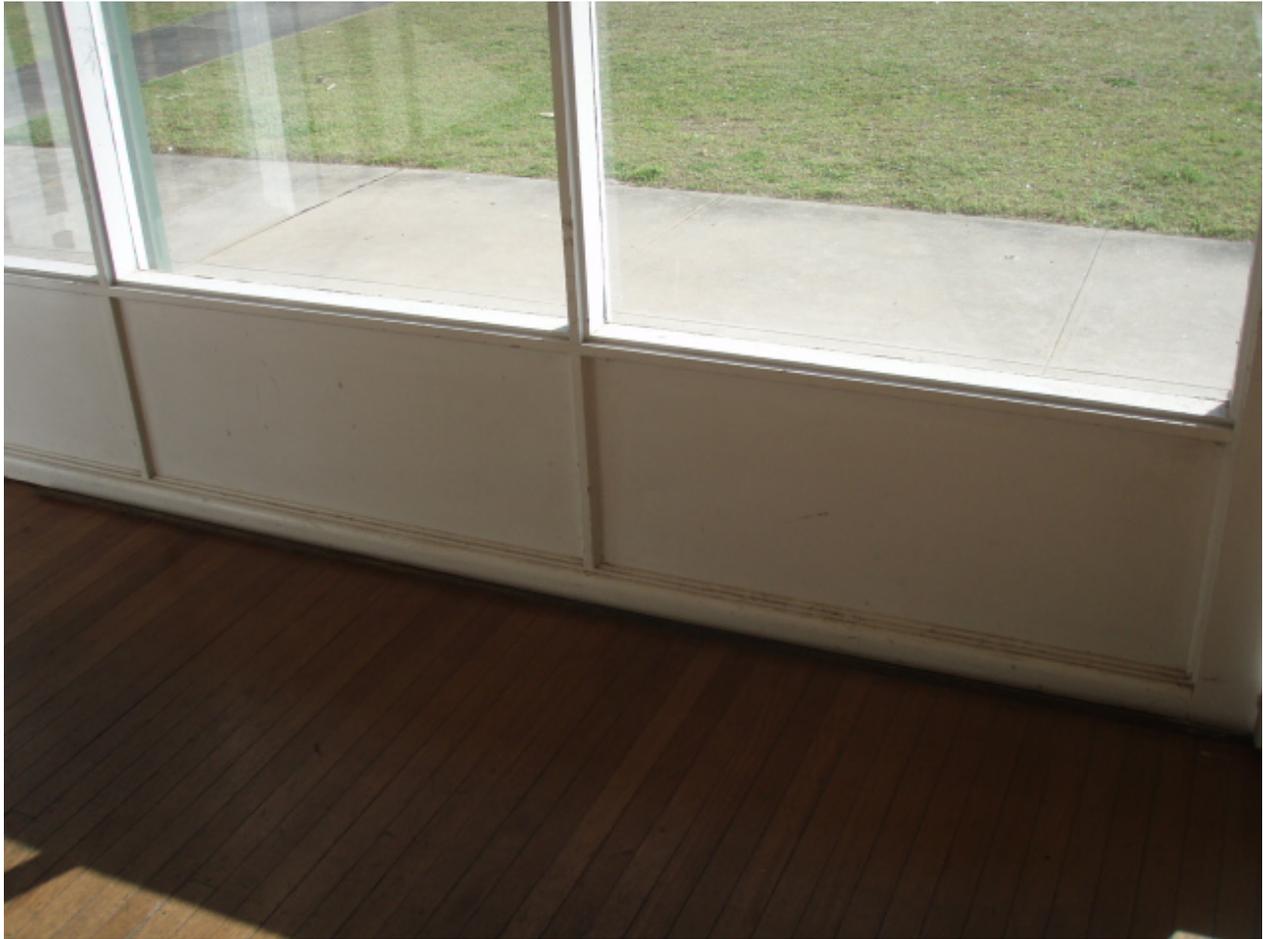
Photo 6

Fibre cement sheeting to the walls below the windows in the hall.

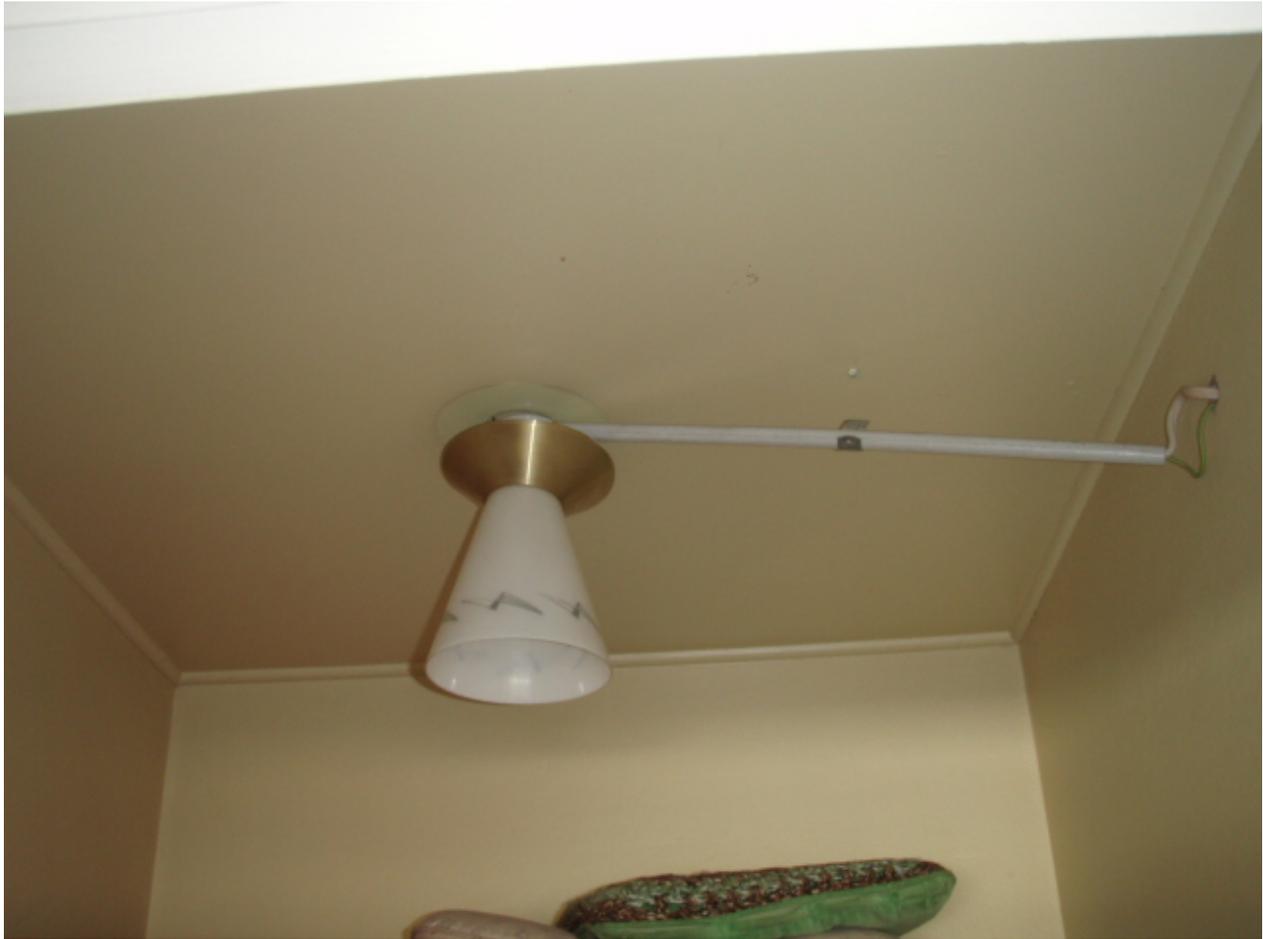
Photo 8

Fibre cement ceiling in the storeroom adjoining the hall.

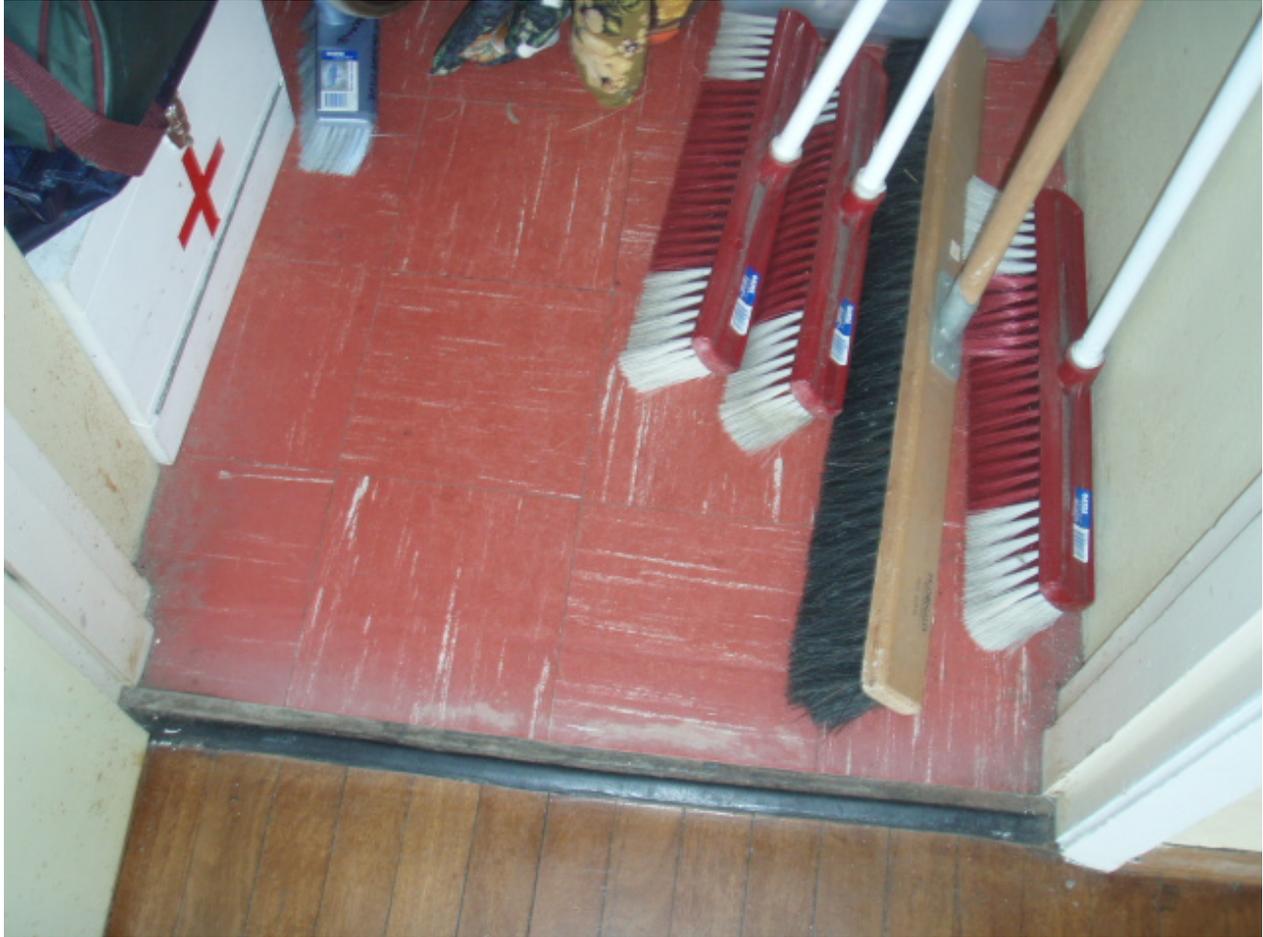
Photo 9

Red vinyl floor tiles in the storeroom adjoining the hall.

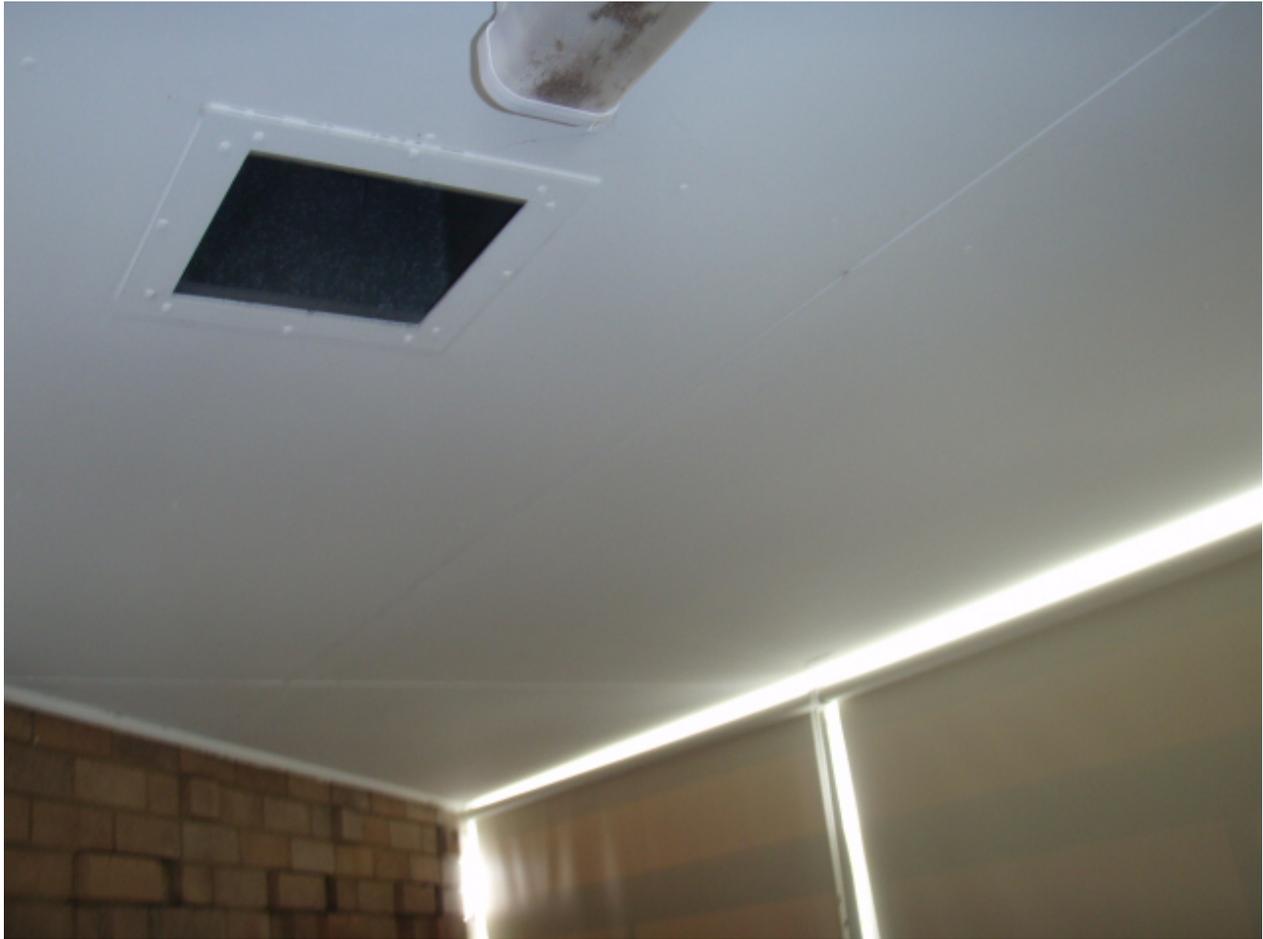
Photo 10

Fibre cement ceiling in the workshop.

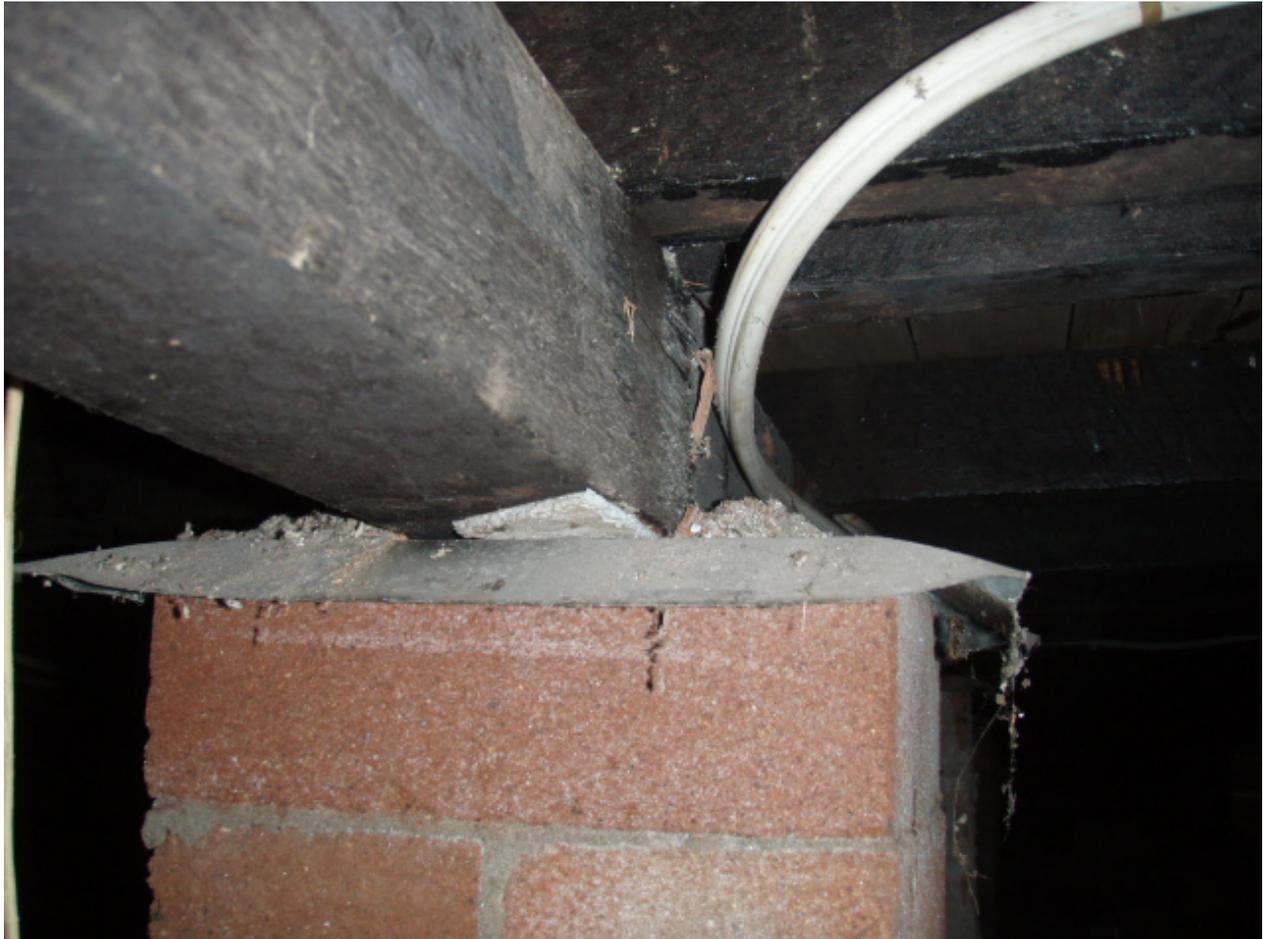
Photo 12

Fibre cement packing (spacers) between the piers and bearers in the subfloor.

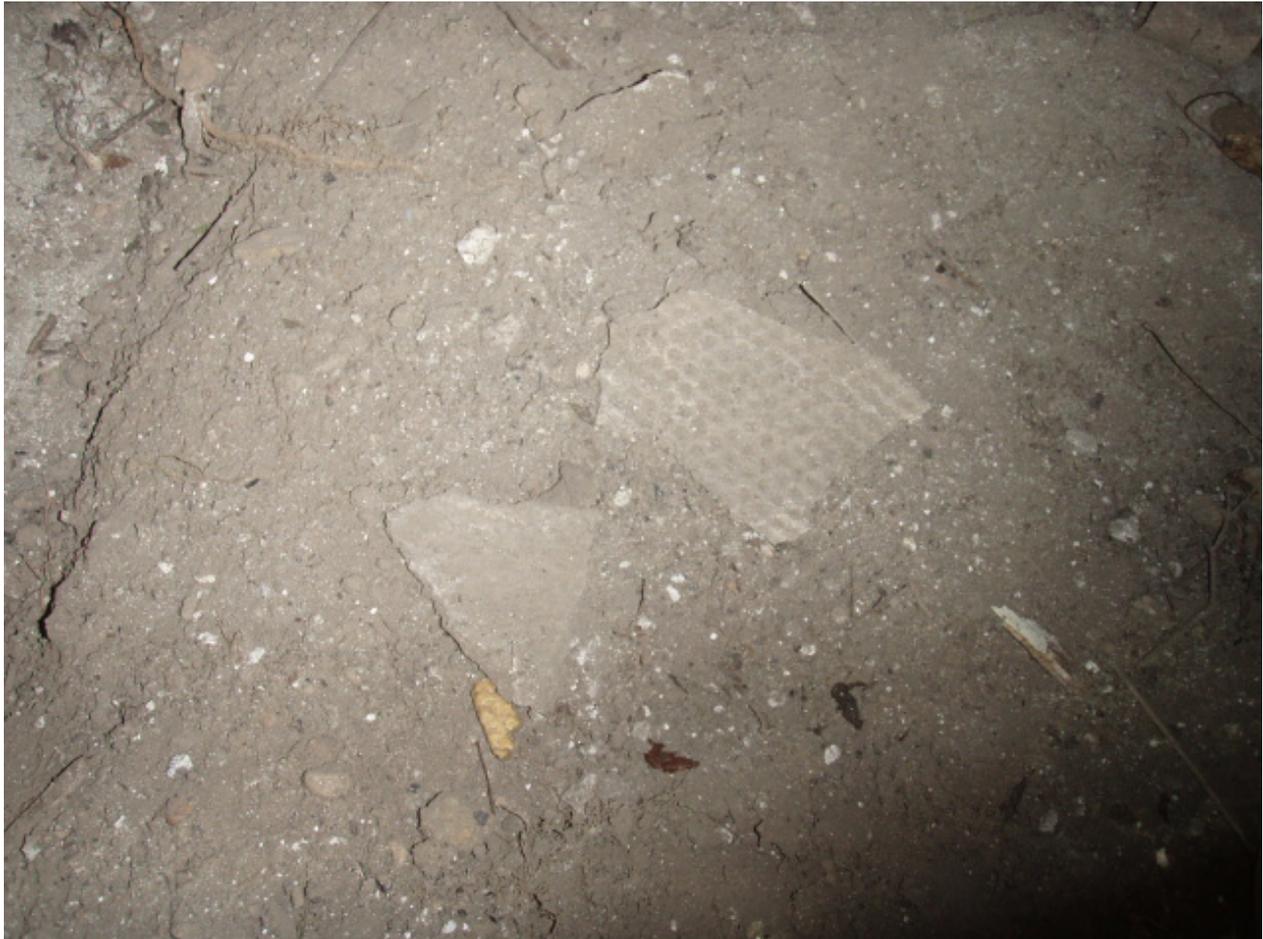
Photo 13

Location Item or Material Description Comments	Sample ID	Asbestos Type	Condition	Friability	Disturbance Potential / Accessibility	Risk Assessment Risk Rating	Quantity	Photo No.
<b>Subfloor</b>								
Fibre cement sheeting and fragments on the ground in various location in the subfloor.	Similar to Reference-2	Similar positive	Moderate	Non friable	Medium	Low	2m <sup>2</sup>	13
<b>Control Recommendation</b>	Choose a building block.							
<b>Electrical Meter Box</b>								
Black 'Zelemite' pitch-based electrical backing board in the electrical meter box.	-	Presumed	Moderate	Non friable	Low	Low	1m <sup>2</sup>	14
<b>Control Recommendation</b>	<p>Affix warning labels. Avoid mechanical damage and abrasion. Remove if refurbishment, structural alteration or demolition is to be carried out in this area. Implement regular inspections, at least annually, or earlier if disturbed or removed.</p> <p>It is likely that the dust and debris in the electrical meter box are contaminated with asbestos. This presents a significant risk of inhalation of airborne asbestos fibres to persons utilising the electrical meter box. The dust and debris in the electrical meter box should be presumed to contain asbestos and should be removed as soon as practicable. Restrict access to the electrical meter box.</p>

Fibre cement sheeting and fragments on the ground in the subfloor.

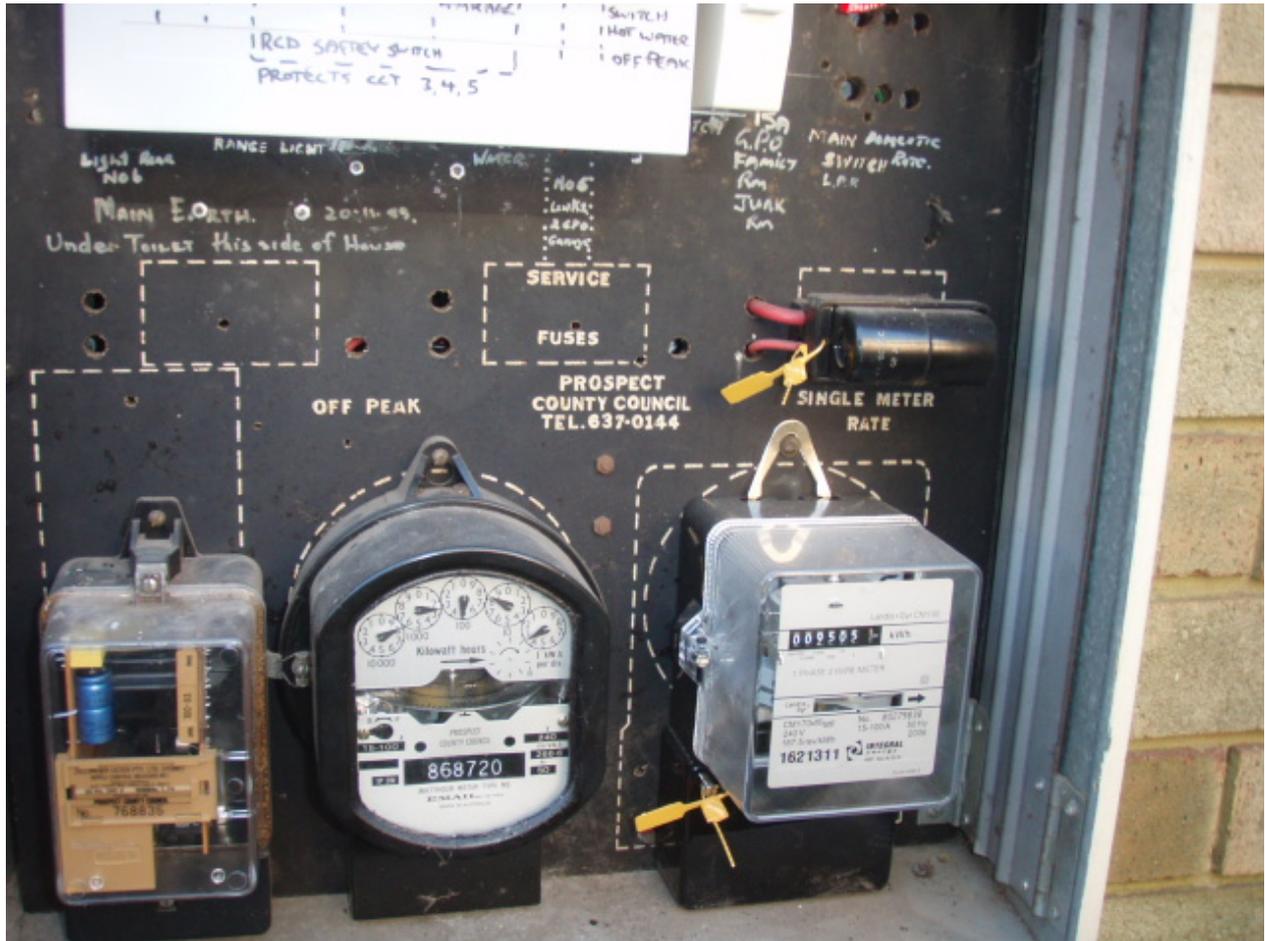
Photo 14

Black 'Zelemite' pitch-based electrical backing board in the electrical meter box.
