Asbestos Inspection Report

Property: Address deleted

Date of Inspection: 10 July 2008

Date of Report: 15 July 2008

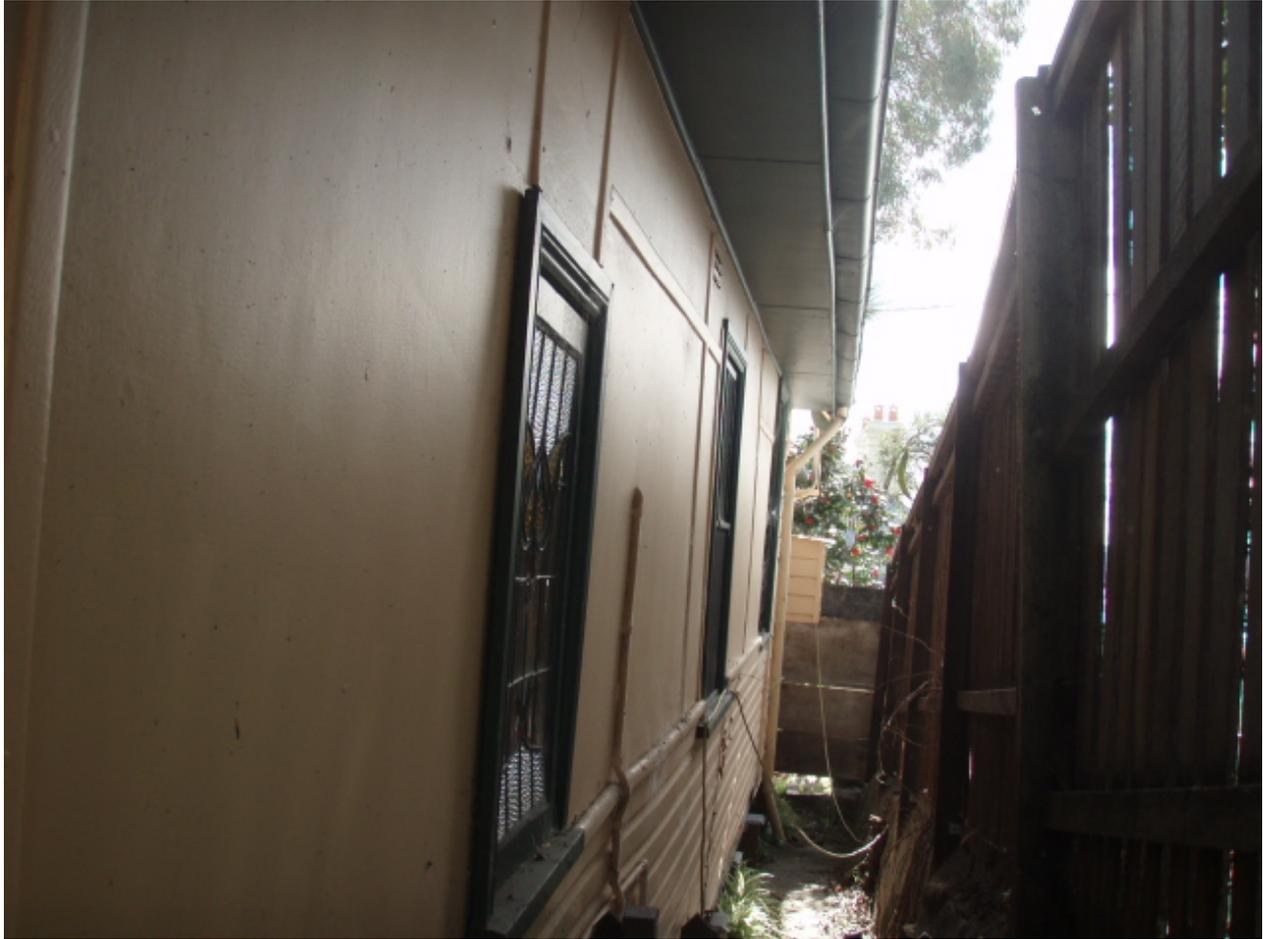
Location Item or Material Description Comments	Sample ID	Asbestos Type	Condition	Friability	Disturbance Potential / Accessibility	Risk Assessment Risk Rating	Quantity	Photo No.
Exterior								
Fibre cement sheeting to the left hand side and right hand side walls to the building, including behind the timber weatherboards to the right hand side wall to the exterior of the bathroom. Cracked and damaged behind the timber weatherboards to the right hand side wall to the exterior of the bathroom and around the duct and vent penetration to the left hand side wall to the exterior of the kitchen.	Reference-1	Chrysotile and crocidolite.	Poor	Non friable	High	High	40m ²	1, 2
Control Recommendation	Remove damaged sections as soon as practicable. Avoid further mechanical damage and abrasion. Remove remaining asbestos-containing materials if refurbishment, structural alteration or demolition is to be carried out in this area. Implement regular inspections, at least annually, or earlier if disturbed or removed.

Photo 1: Fibre cement sheeting to the left hand side and right hand side walls to the building.

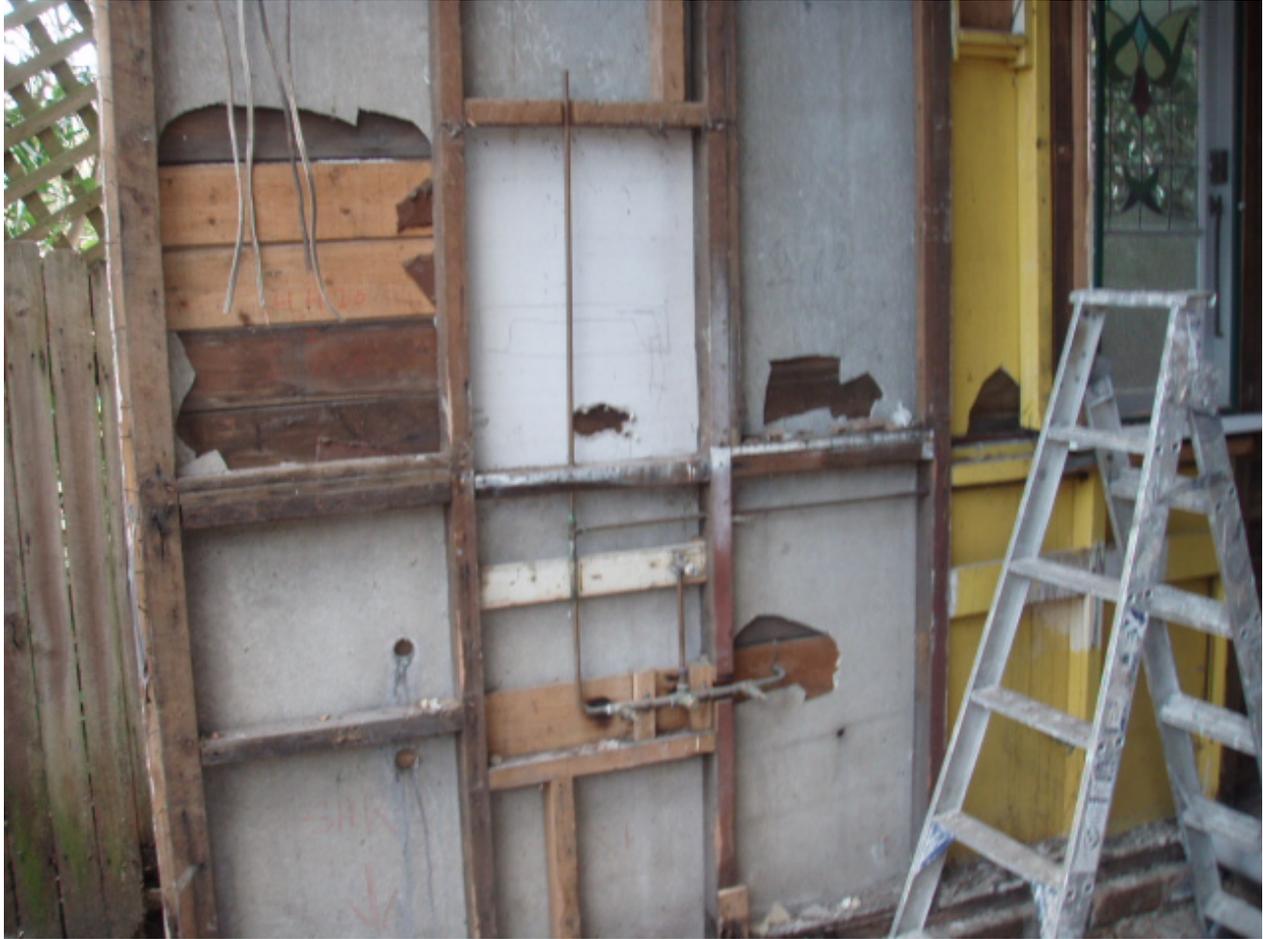
Photo 2: Fibre cement sheeting behind the timber weatherboards to the right hand side wall to the building to the exterior of the bathroom.

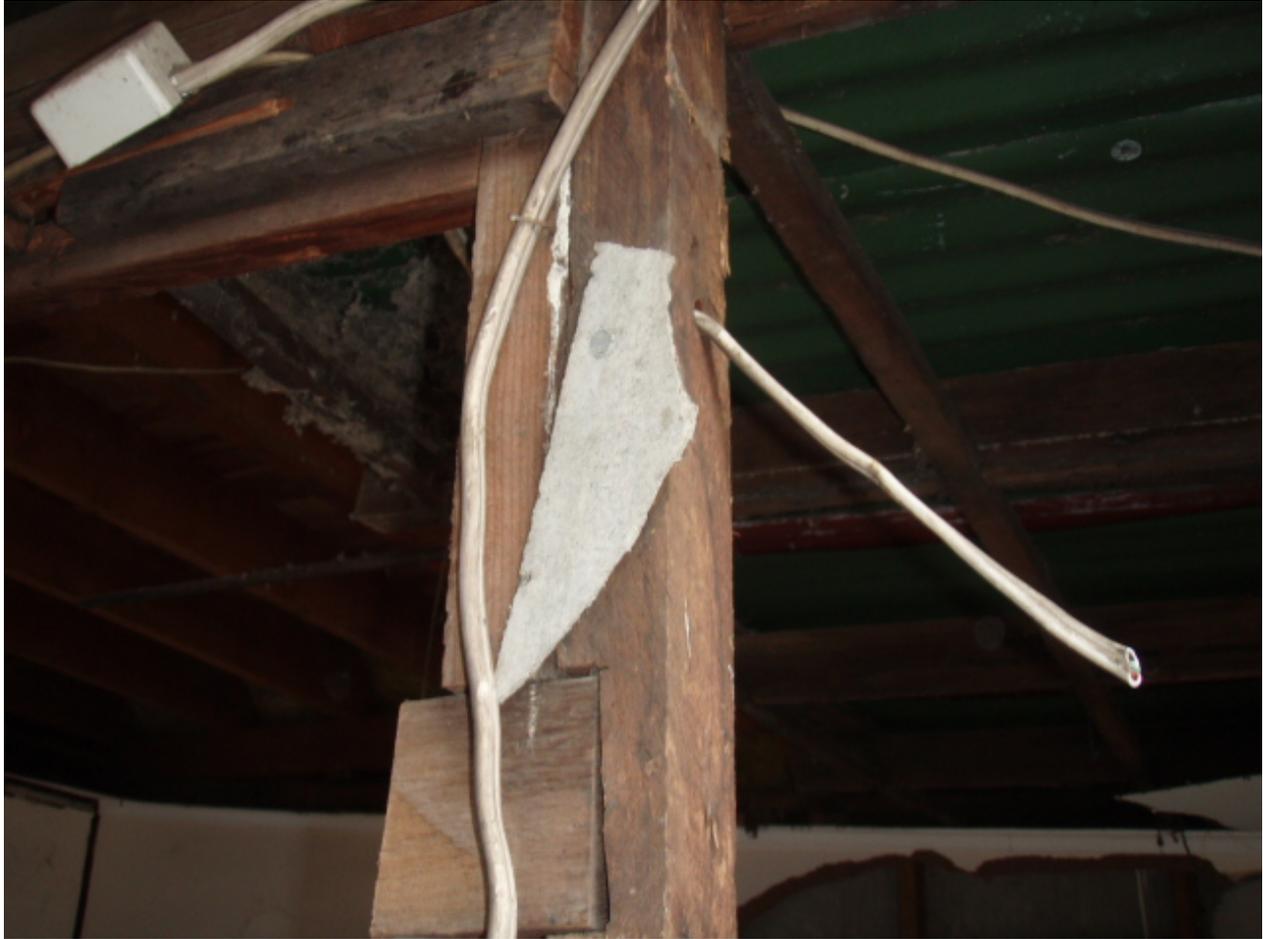
Exterior								
Fibre cement sheet fragments to the timber framework to the rear wall to the building to the right hand side of the kitchen. Cracked and damaged.	Similar to Reference-1	Similar positive	Poor	Non friable	High	High	Less than 1m ²	3
Control Recommendation	Remove as soon as practicable. Avoid further mechanical damage and abrasion. Implement regular inspections, at least annually, or earlier if disturbed or removed.							
Roof								
Fibre cement eaves to the left hand side and right hand side of the roof.	Similar to Reference-1	Similar positive	Good	Non friable	Low	Low	10m ²	4
Control Recommendation	Avoid mechanical damage and abrasion. Remove if refurbishment, structural alteration or demolition is to be carried out in this area. Implement regular inspections, at least annually, or earlier if disturbed or removed.							
Roof								
Fibre cement eaves to the front and rear of the gabled roof.	Reference-2	Chrysotile	Good	Non friable	Low	Low	12m ²	12

Photo 3: Fibre cement sheet fragments to the timber framework to the rear wall to the building to the right hand side of the kitchen.

Control Recommendation	Avoid mechanical damage and abrasion. Remove if refurbishment, structural alteration or demolition is to be carried out in this area. Implement regular inspections, at least annually, or earlier if disturbed or removed.

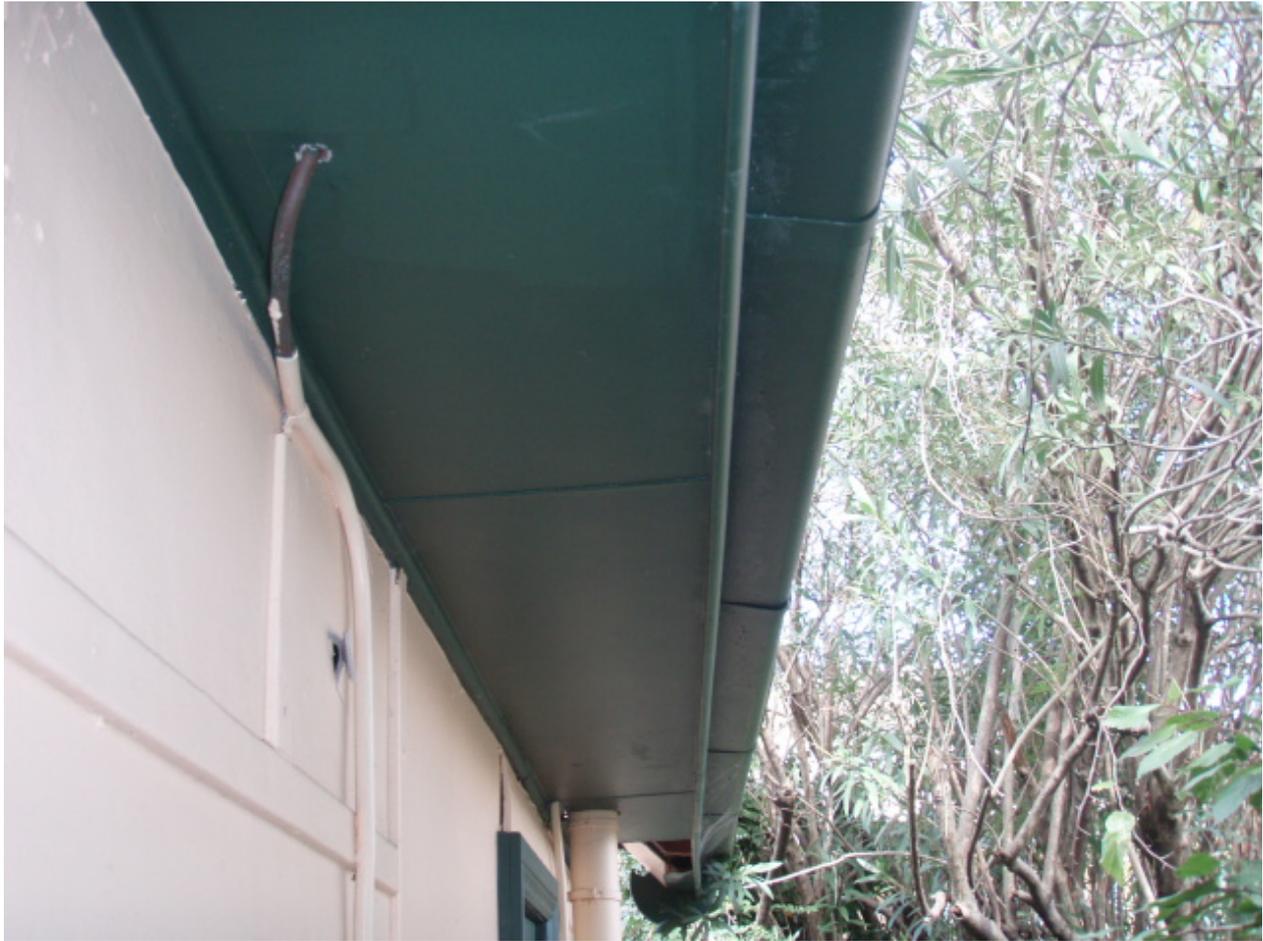
Photo 4: Fibre cement eaves to the left hand side and right hand side of the roof.

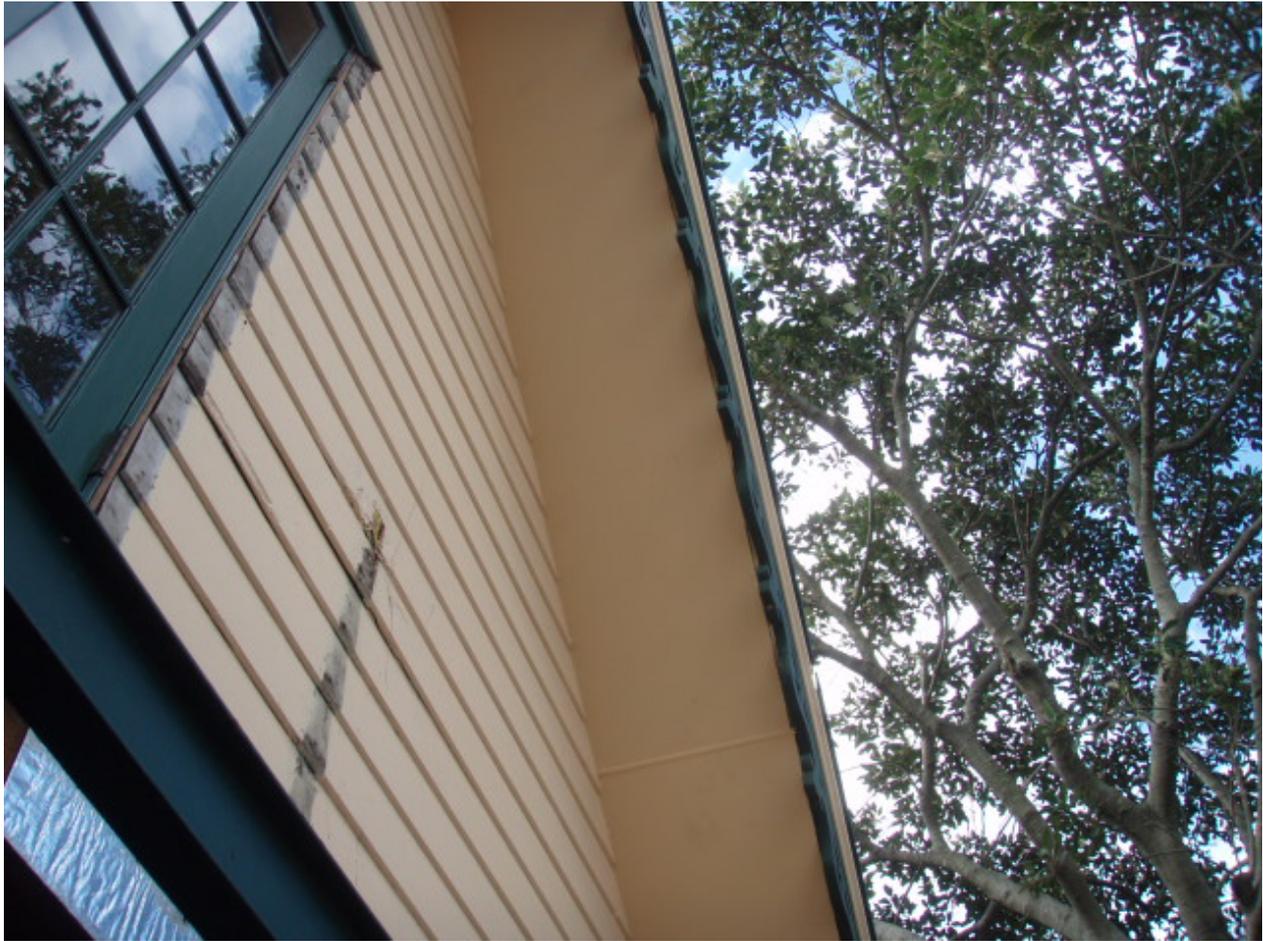
Photo 5: Fibre cement eaves to the front and rear of the gabled roof.

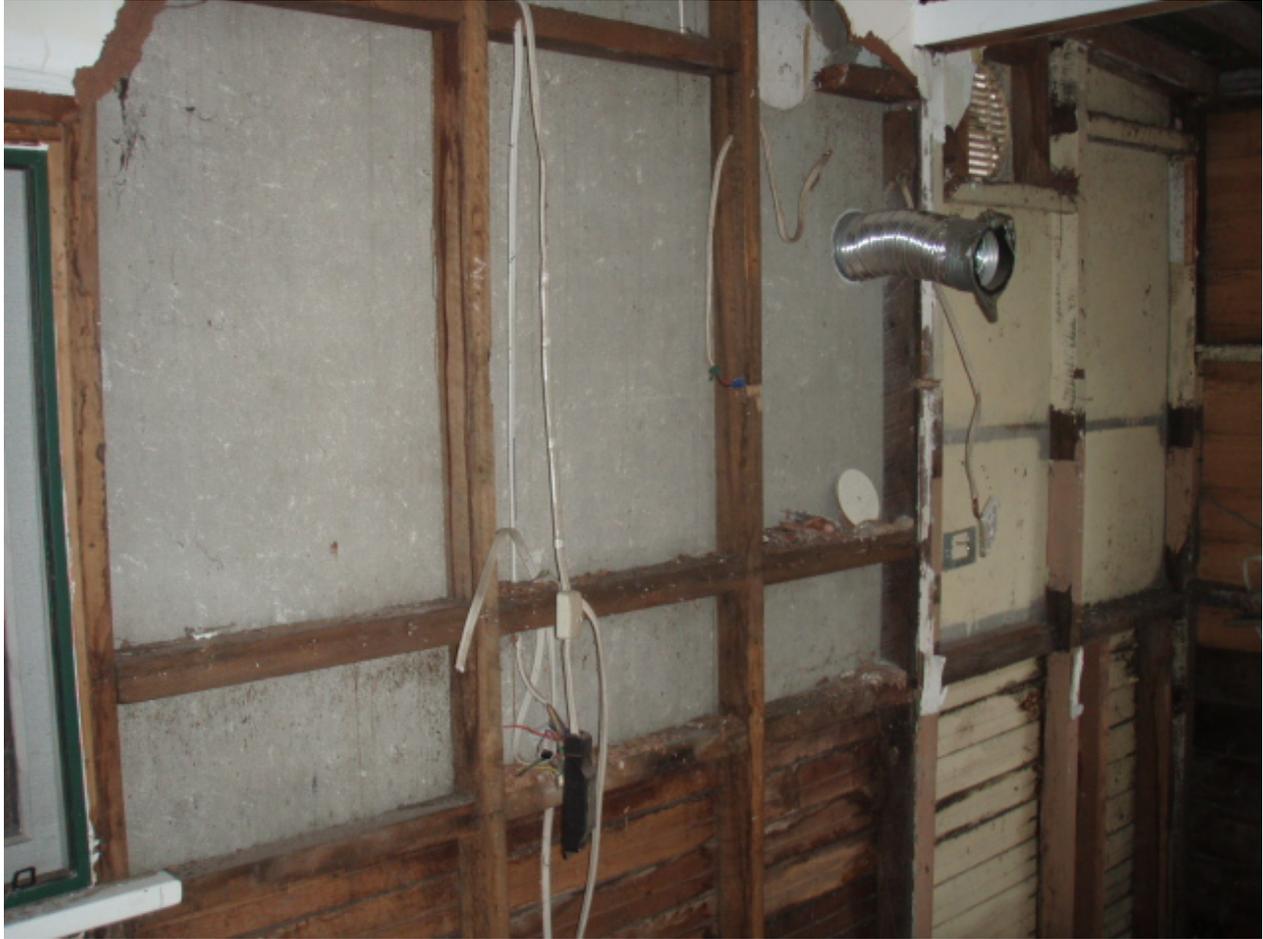
Location Item or Material Description Comments	Sample ID	Asbestos Type	Condition	Friability	Disturbance Potential / Accessibility	Risk Assessment Risk Rating	Quantity	Photo No.
Entry / Hallway								
No asbestos-containing materials were evident in the entry/hallway.								
Bedroom 2 (Ground Floor Front Right Hand Side)								
No asbestos-containing materials were evident in bedroom 2.								
Bedroom 3 (Ground Floor Right Hand Side)								
No asbestos-containing materials were evident in bedroom 3.								
Lounge Room (Ground Floor Left Hand Side)								
No asbestos-containing materials were evident in the lounge room.								
Kitchen								
Fibre cement sheeting to the left hand side wall to the building, the inside surface of which is visible in the kitchen. Cracked and damaged around duct and vent penetrations.	Similar to Reference-1	Similar positive	Poor	Non friable	High	High	6m ² visible	6

Photo 6: Fibre cement sheeting to the left hand side wall to the building, the inside surface of which is visible to the left hand side wall in the kitchen.

Control Recommendation	Remove damaged sections as soon as practicable. Avoid further mechanical damage and abrasion. Remove remaining asbestos-containing materials if refurbishment, structural alteration or demolition is to be carried out in this area. Implement regular inspections, at least annually, or earlier if disturbed or removed.							
Kitchen								
Fibre cement sheeting and fragments to the timber framework to the left hand side, right hand side and rear walls in the kitchen, including around the nails Cracked and damaged.	Reference-3	Chrysotile	Poor	Non friable	High	High	1m ²	7, 8, 9, 10
Control Recommendation	Remove as soon as practicable. Avoid further mechanical damage and abrasion. Implement regular inspections, at least annually, or earlier if disturbed or removed.

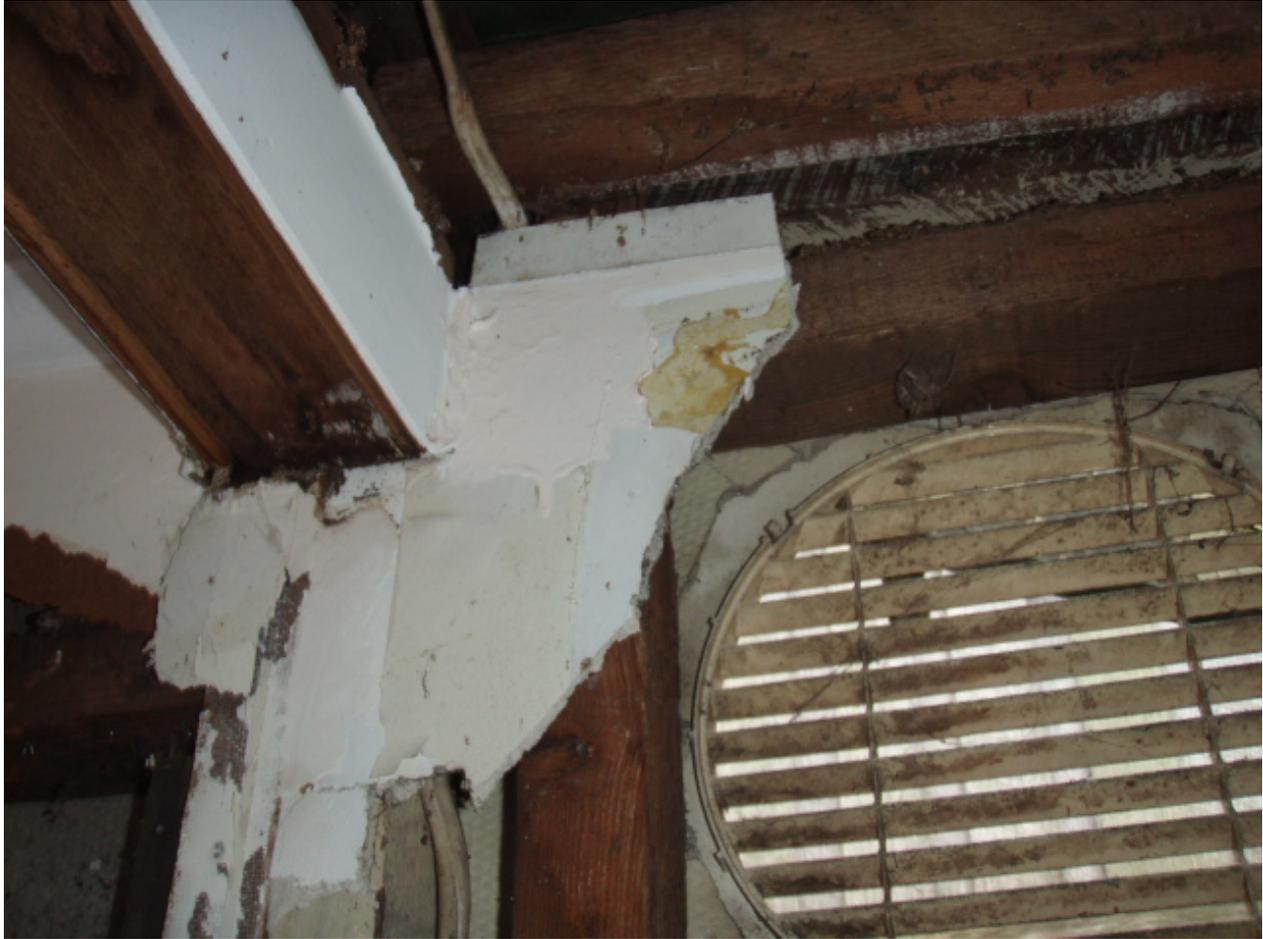
Photo 7: Fibre cement sheeting to the timber framework to the left hand side wall in the kitchen.

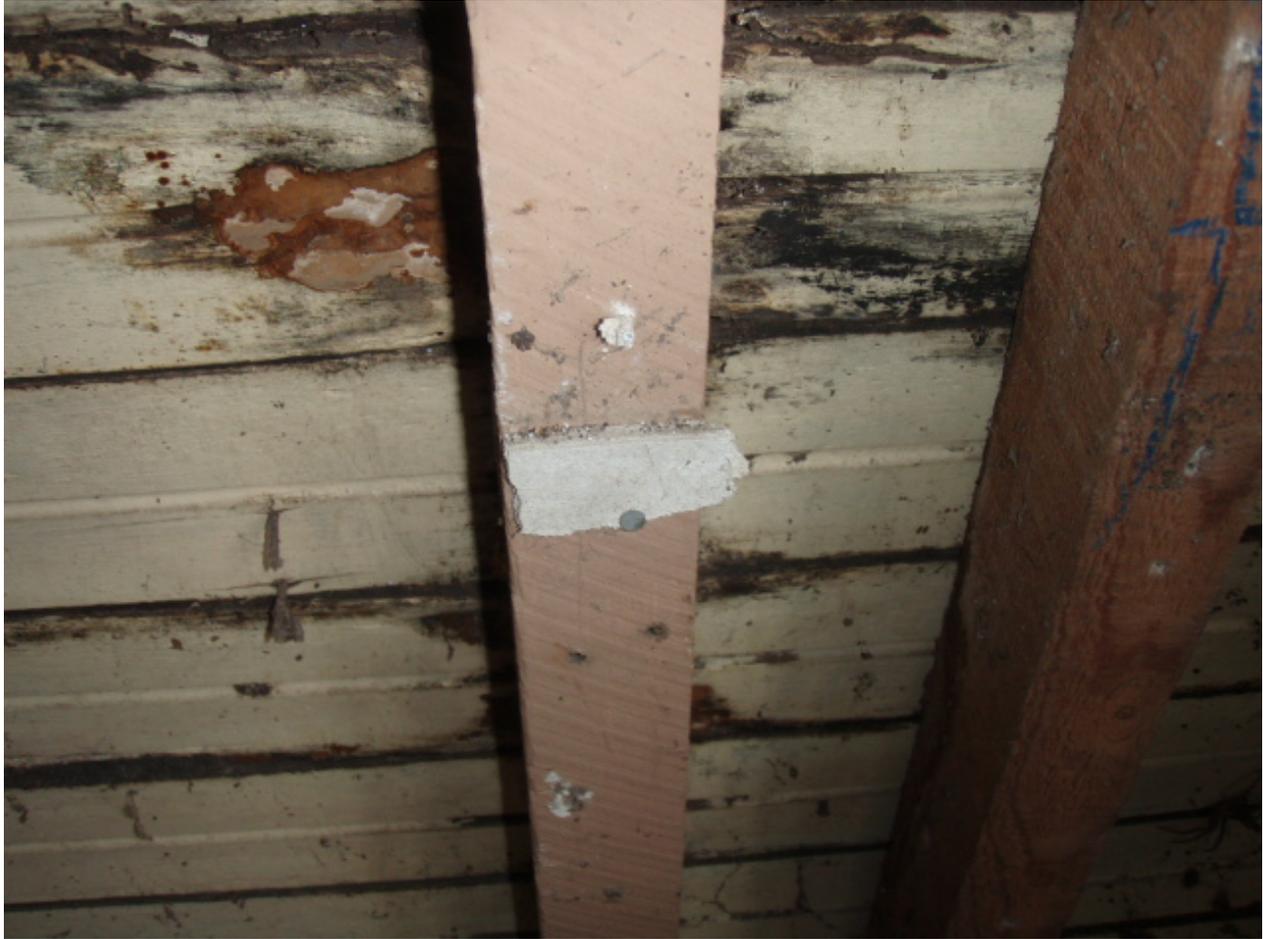
Photo 8: Fibre cement sheet fragment to the timber framework to the left hand side wall in the kitchen.

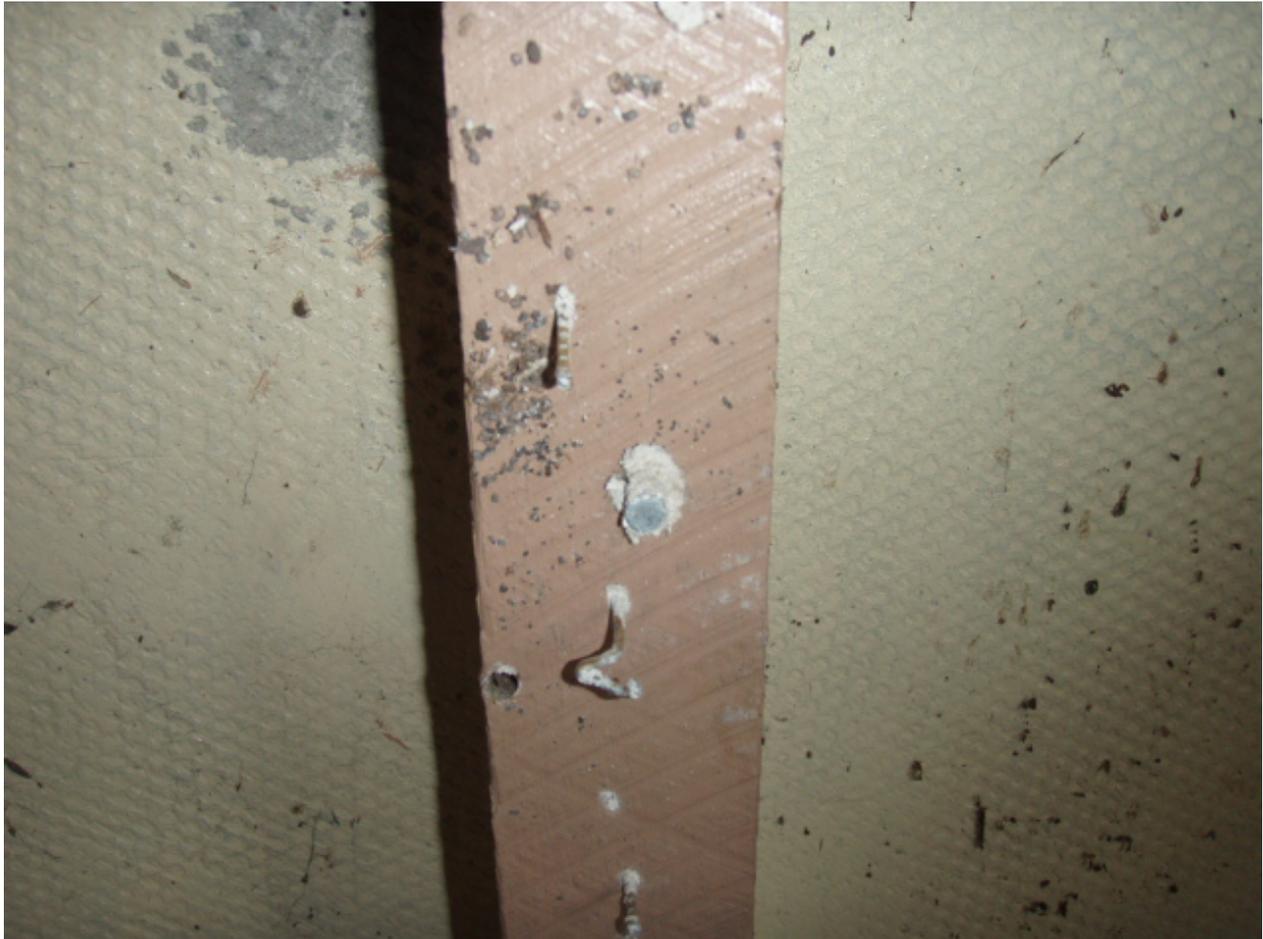
Photo 9: Fibre cement sheet fragments around the nails to the timber framework to the left hand side wall in the kitchen.

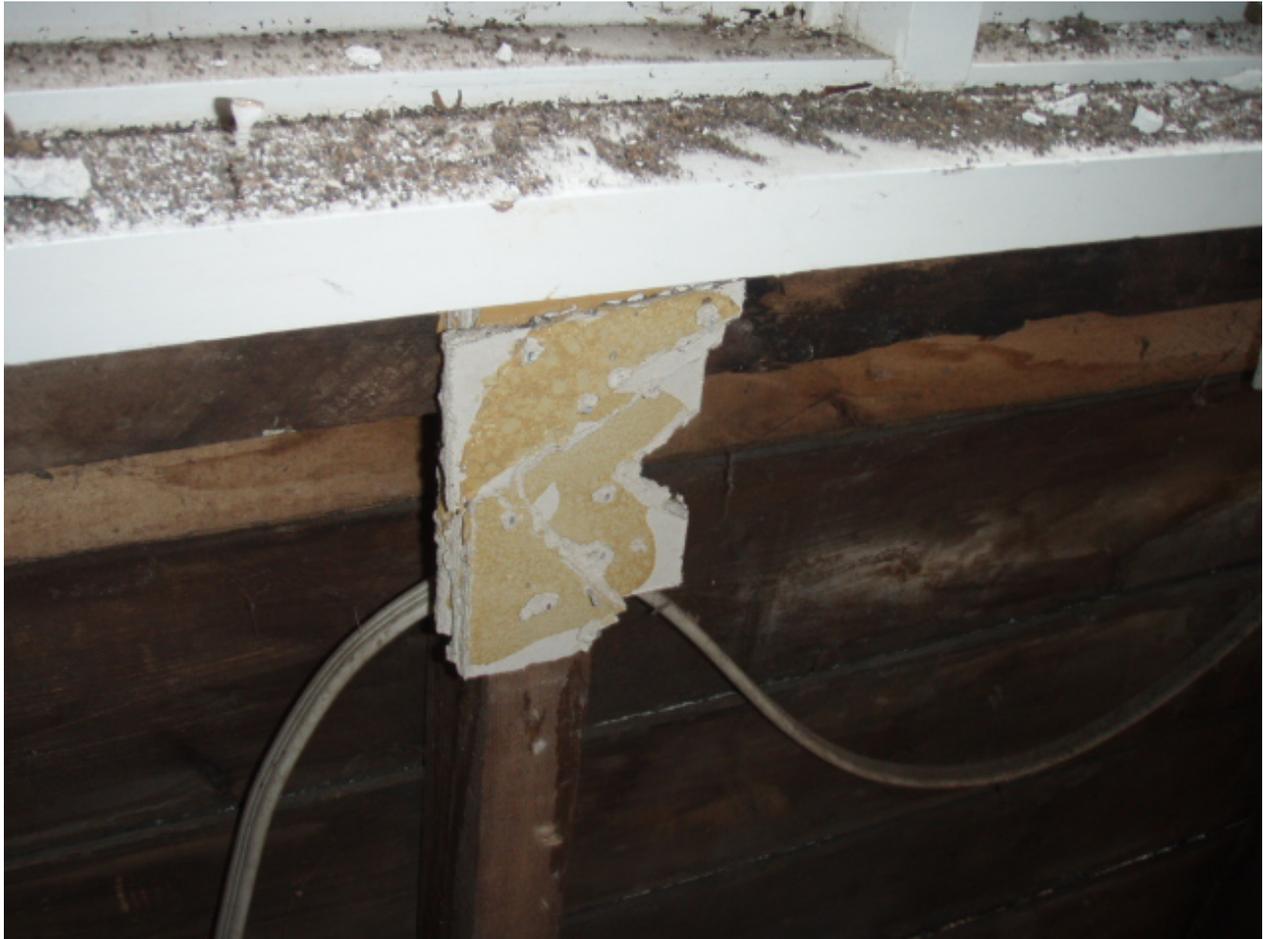
Photo 10: Fibre cement sheeting to the timber framework to the rear wall in the kitchen.

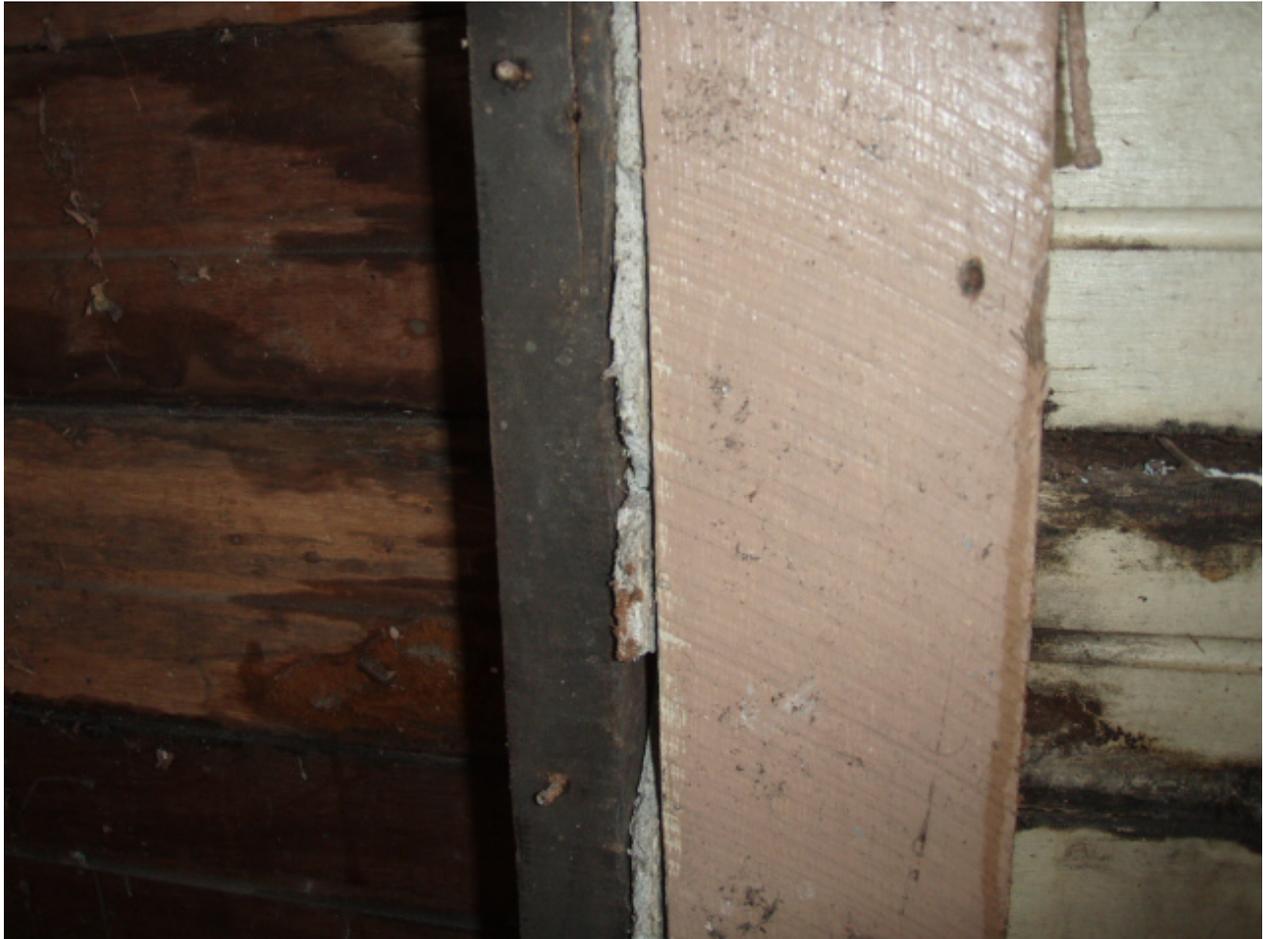
Location Item or Material Description Comments	Sample ID	Asbestos Type	Condition	Friability	Disturbance Potential / Accessibility	Risk Assessment Risk Rating	Quantity	Photo No.
Kitchen								
Fibre cement sheeting between the timber framework to the left hand side wall in the kitchen. Cracked and damaged.	Similar to Reference-1	Similar positive	Poor	Non friable	High	High	1m ²	11
Control Recommendation	Remove as soon as practicable. Avoid further mechanical damage and abrasion. Implement regular inspections, at least annually, or earlier if disturbed or removed.							
Kitchen								
Fibre cement sheeting and fragments to the ceiling joists in the kitchen, including around the nails. cracked and damaged.	Similar to Reference-3	Similar positive	Poor	Non friable	High	High	Less than 1m ²	12
Control Recommendation	Remove as soon as practicable. Avoid further mechanical damage and abrasion. Implement regular inspections, at least annually, or earlier if disturbed or removed.

Photo 11: Fibre cement sheeting between the timber framework to the left hand side wall in the kitchen.

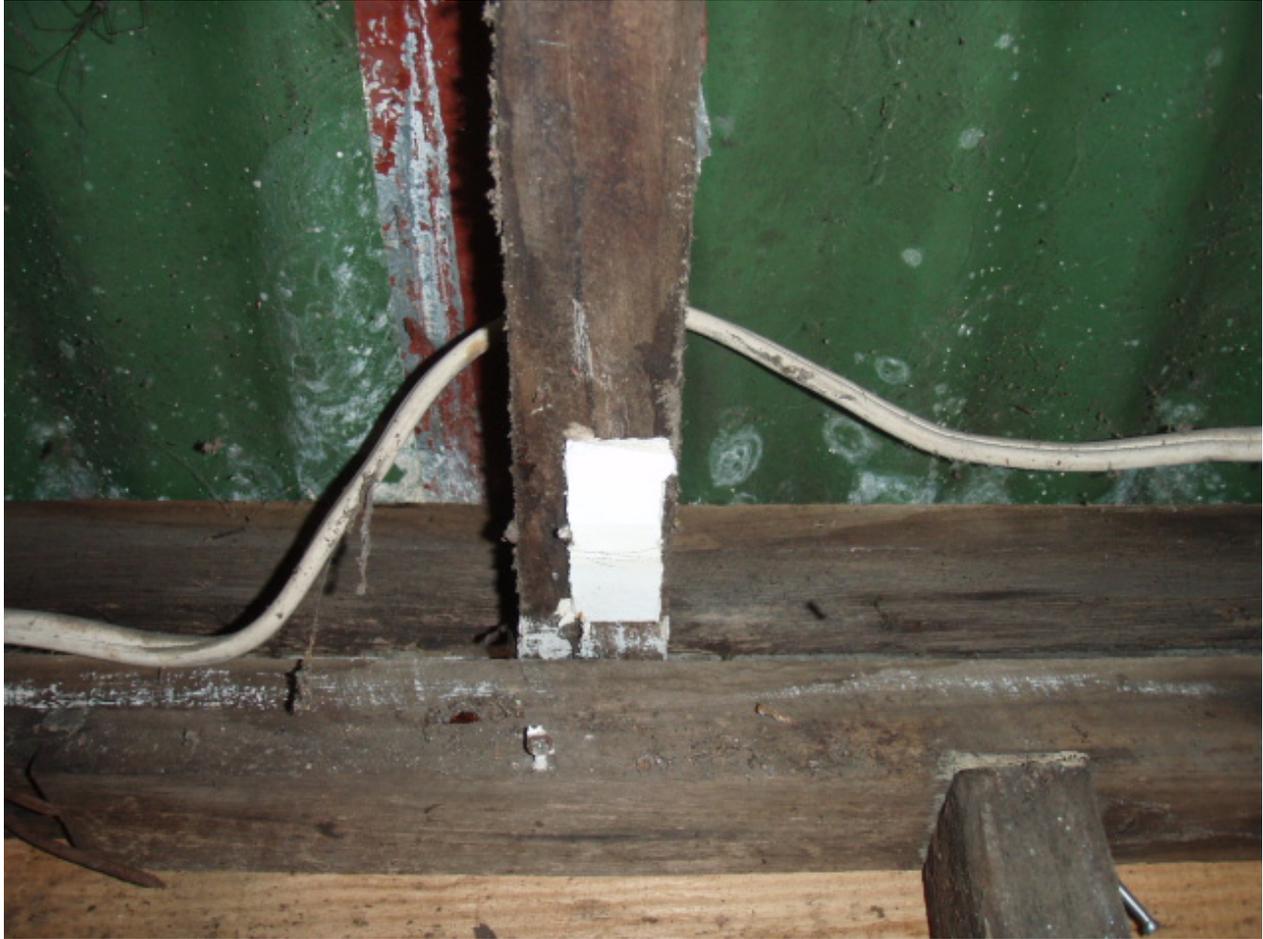
Photo 12: Fibre cement sheeting and fragments to the ceiling joists in the kitchen.

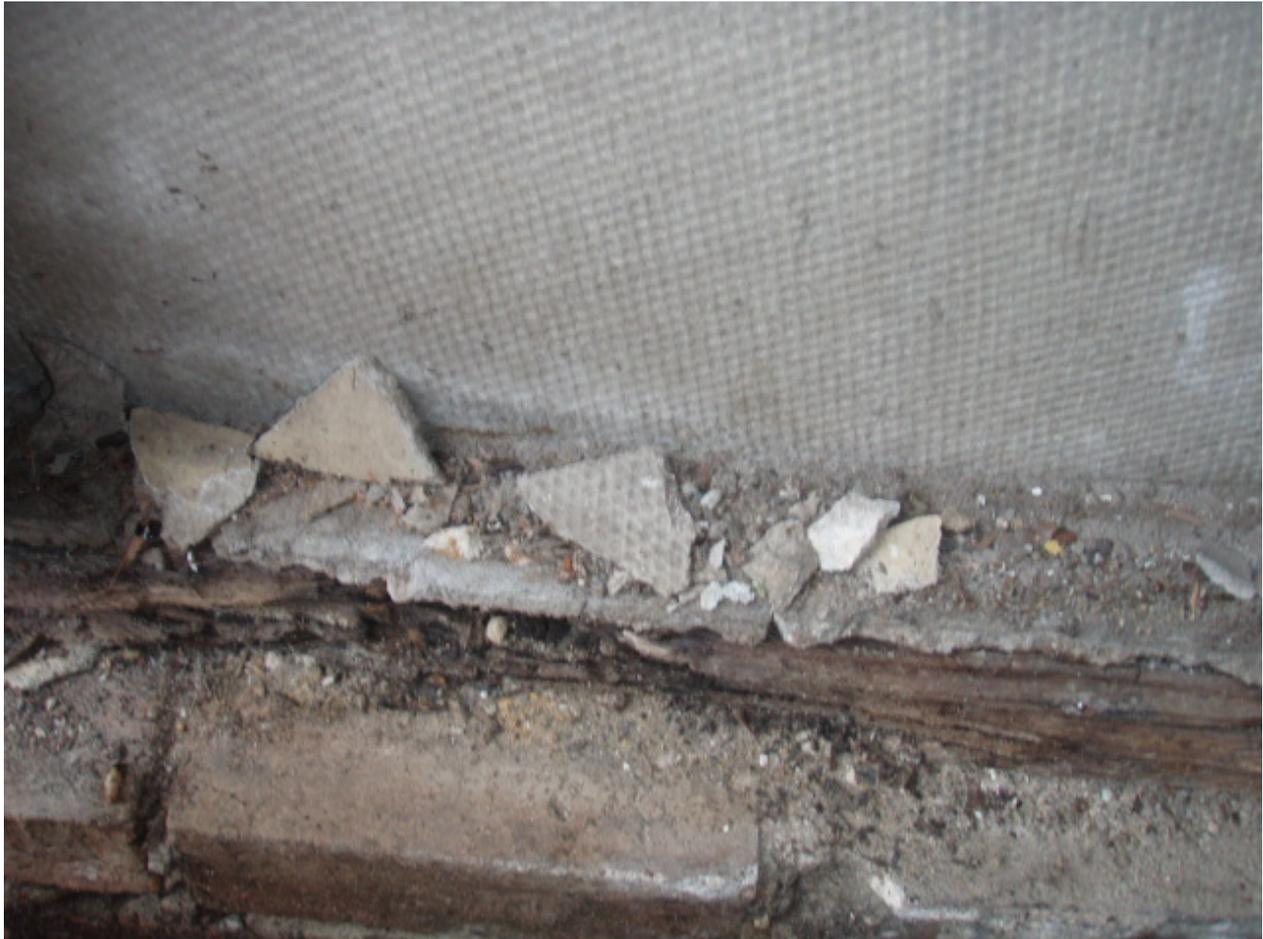
Location Item or Material Description Comments	Sample ID	Asbestos Type	Condition	Friability	Disturbance Potential / Accessibility	Risk Assessment Risk Rating	Quantity	Photo No.
Bathroom								
Fibre cement sheet fragments on the horizontal timber framework to the right hand side wall in the bathroom. Cracked and damaged.	Similar to Reference-1	Similar positive	Poor	Non friable	High	High	Less than 1m ²	13
Control Recommendation	Remove as soon as practicable. Avoid further mechanical damage and abrasion. Implement regular inspections, at least annually, or earlier if disturbed or removed.							
Bathroom								
Fibre cement sheet packing (spacers) between the window and wall frame in the bathroom. Cracked and damaged.	Similar to Reference-1	Similar positive	Poor	Non friable	High	High	Less than 1m ²	14
Control Recommendation	Remove as soon as practicable. Avoid further mechanical damage and abrasion. Implement regular inspections, at least annually, or earlier if disturbed or removed.

Photo 13: Fibre cement sheet fragments on the horizontal timber framework to the right hand side wall in the bathroom.

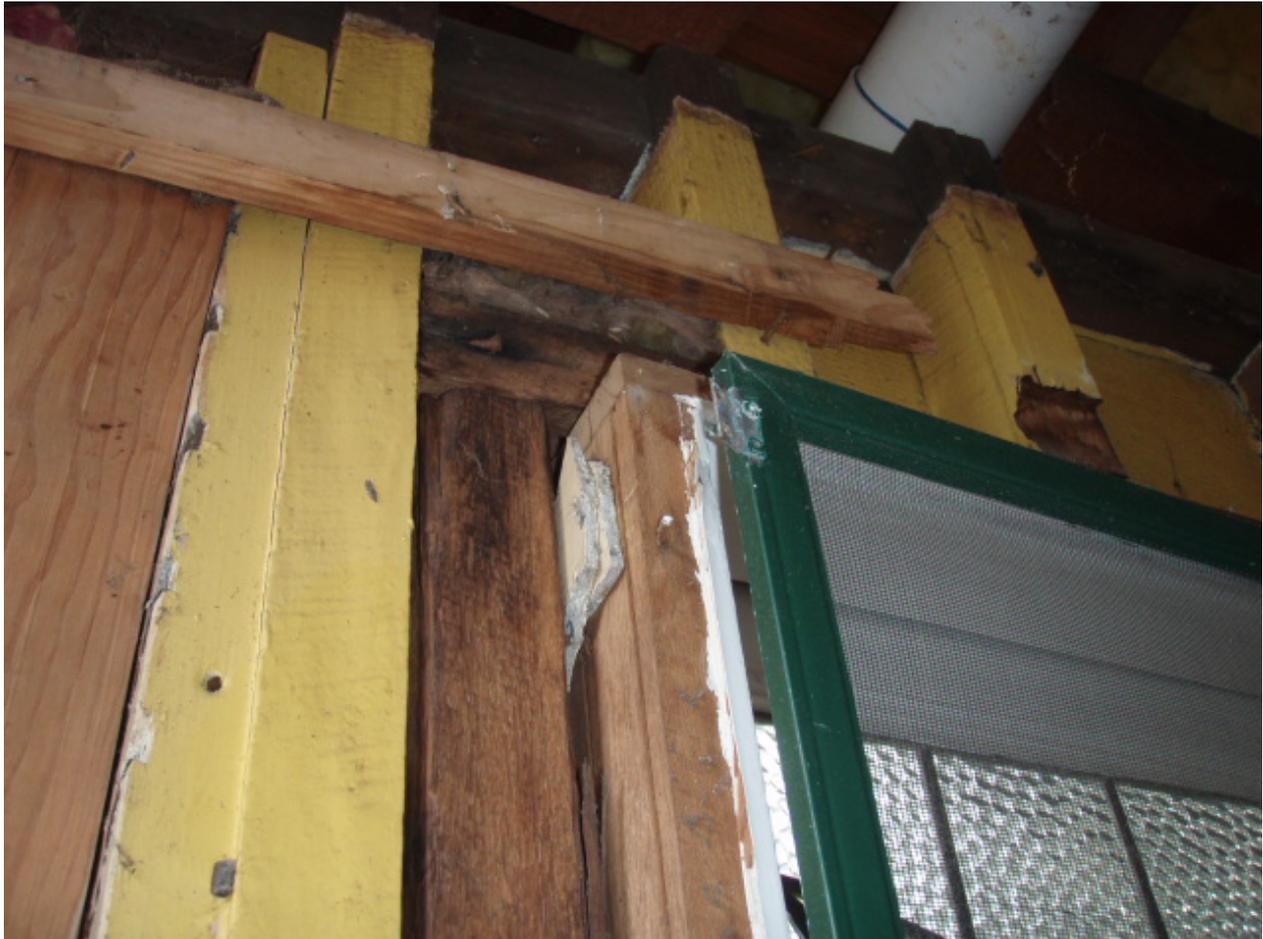
Photo 14: Fibre cement sheet packing (spacers) between the window and wall frame in the bathroom.

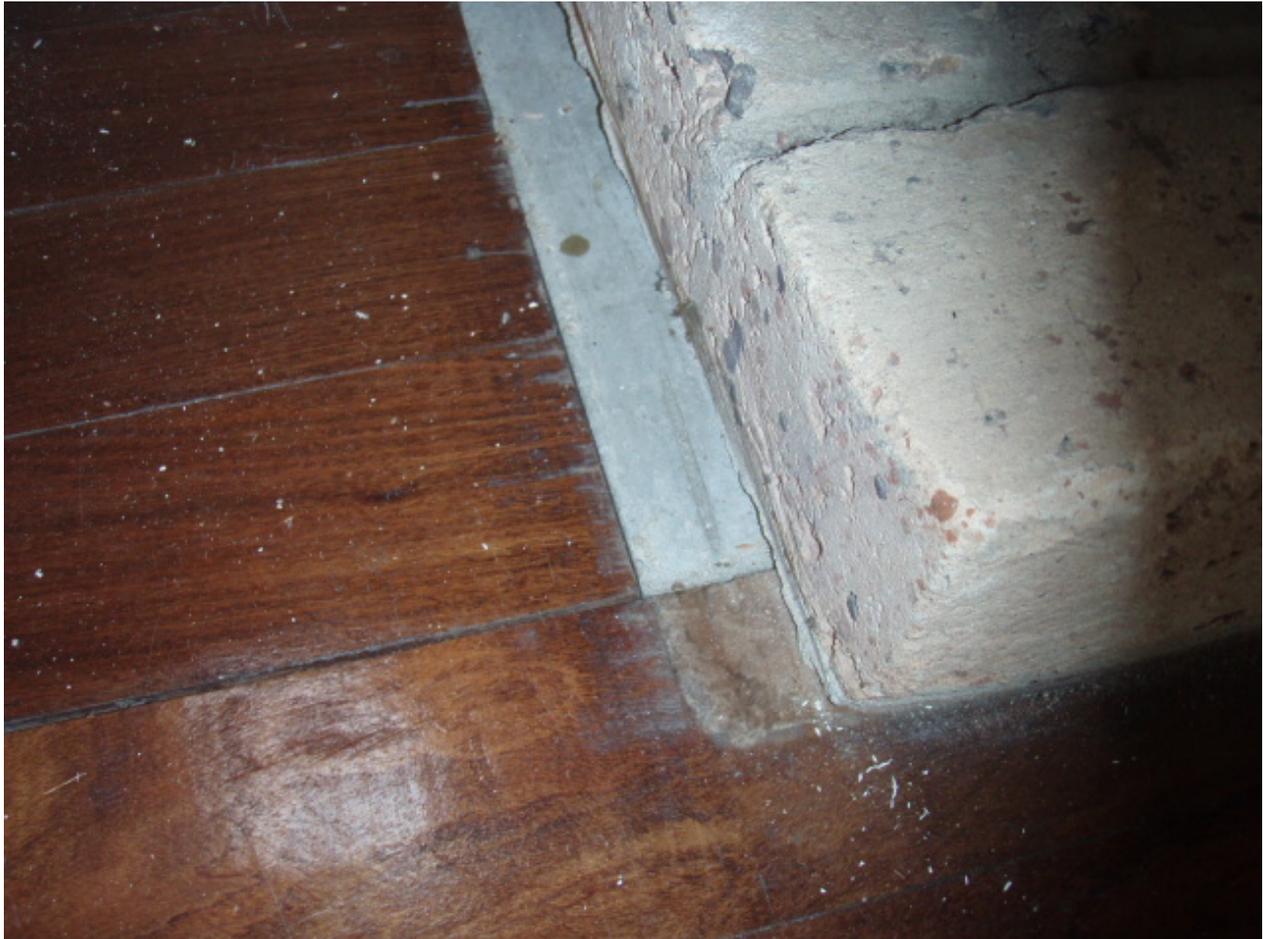
Stairway								
No asbestos-containing materials were evident to the stairway.								
Family Room (First Floor Front)								
Compressed fibre cement sheeting under the brick hearth to the fireplace in the family room.	-	Presumed	Good	Non friable	Low	Low	1m ²	15
Control Recommendation	Avoid mechanical damage and abrasion. Confirm that material contains asbestos by sampling and laboratory analysis prior to removal. Remove if refurbishment, structural alteration or demolition is to be carried out in this area. Implement regular inspections, at least annually, or earlier if disturbed or removed.							
Family Room (First Floor Front)								
Fibre cement sheeting on the first floor front balcony to the family room. Cracked and damaged.	-	Presumed	Poor	Non friable	Medium	Medium	Less than 1m ²	16
Control Recommendation	Remove as soon as practicable. Avoid further mechanical damage and abrasion. Implement regular inspections, at least annually, or earlier if disturbed or removed.

Photo 15: Compressed fibre cement sheeting under the brick hearth to the fireplace in the family room.

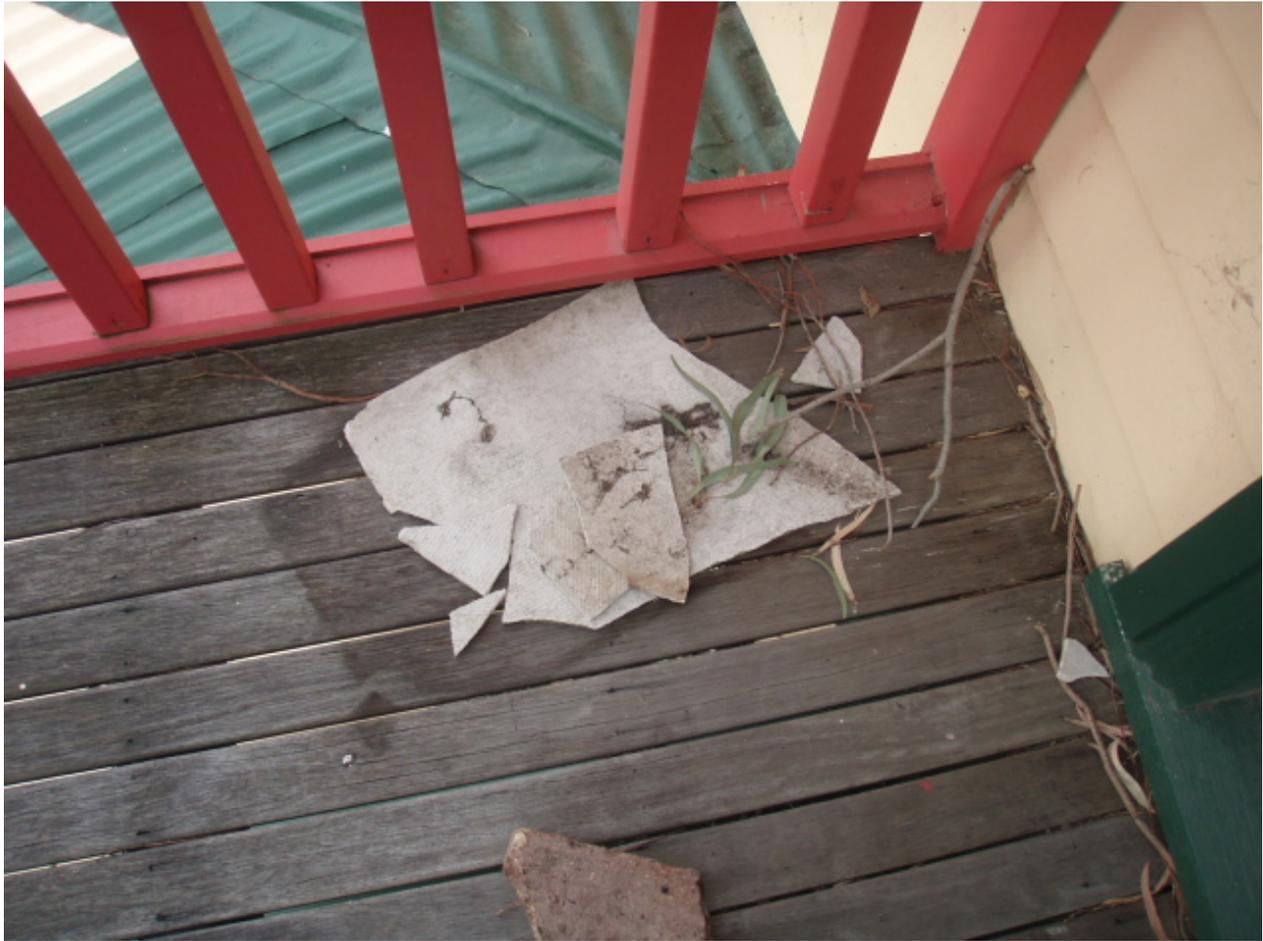
Photo 16: Fibre cement sheeting on the first floor front balcony.

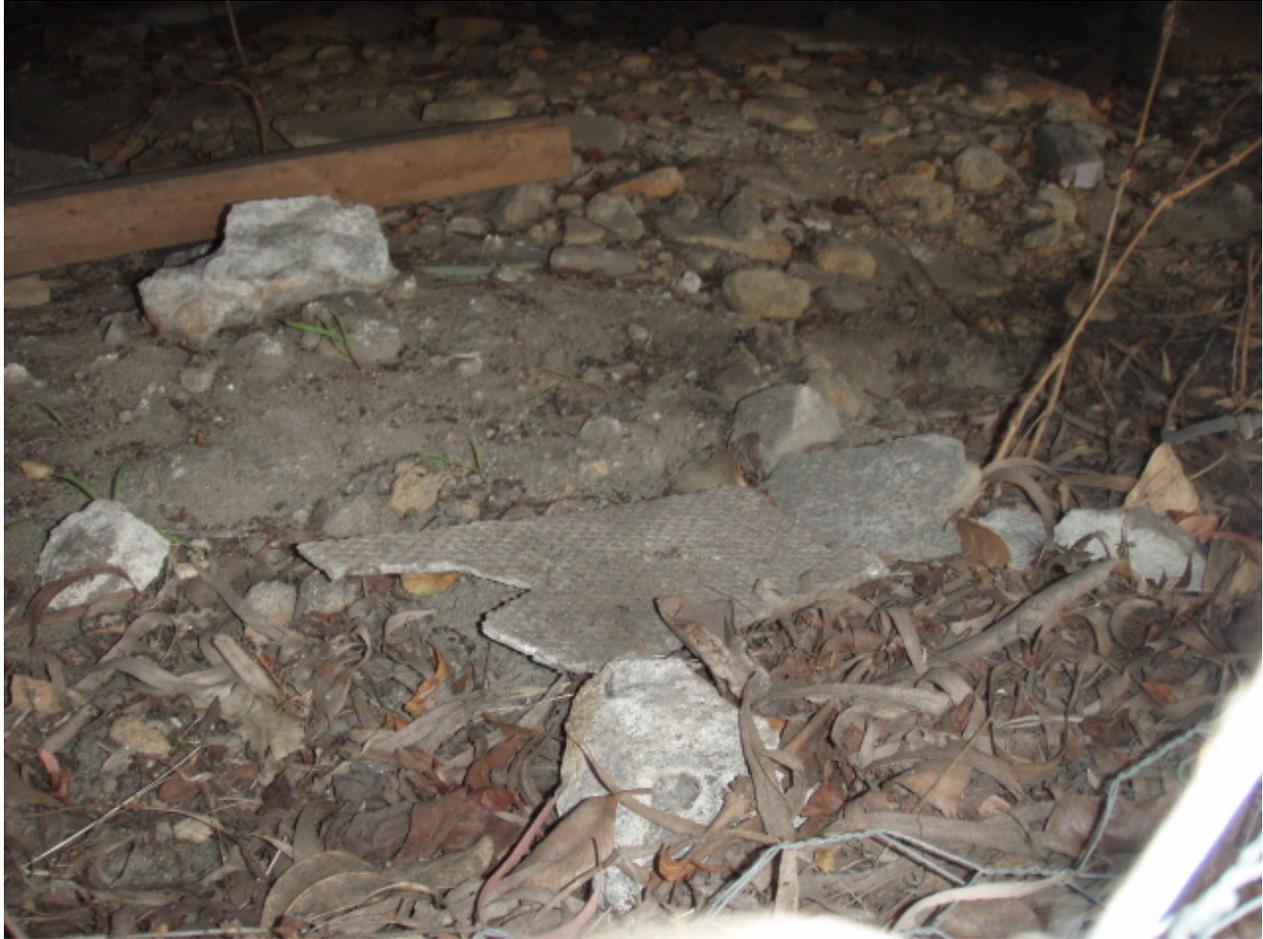
Photo 17: Fibre cement sheeting on the ground in the subfloor under the kitchen.
