Asbestos Inspection Report

Property: Address deleted

Date of Inspection: 10 July 2008

Date of Report: 15 July 2008

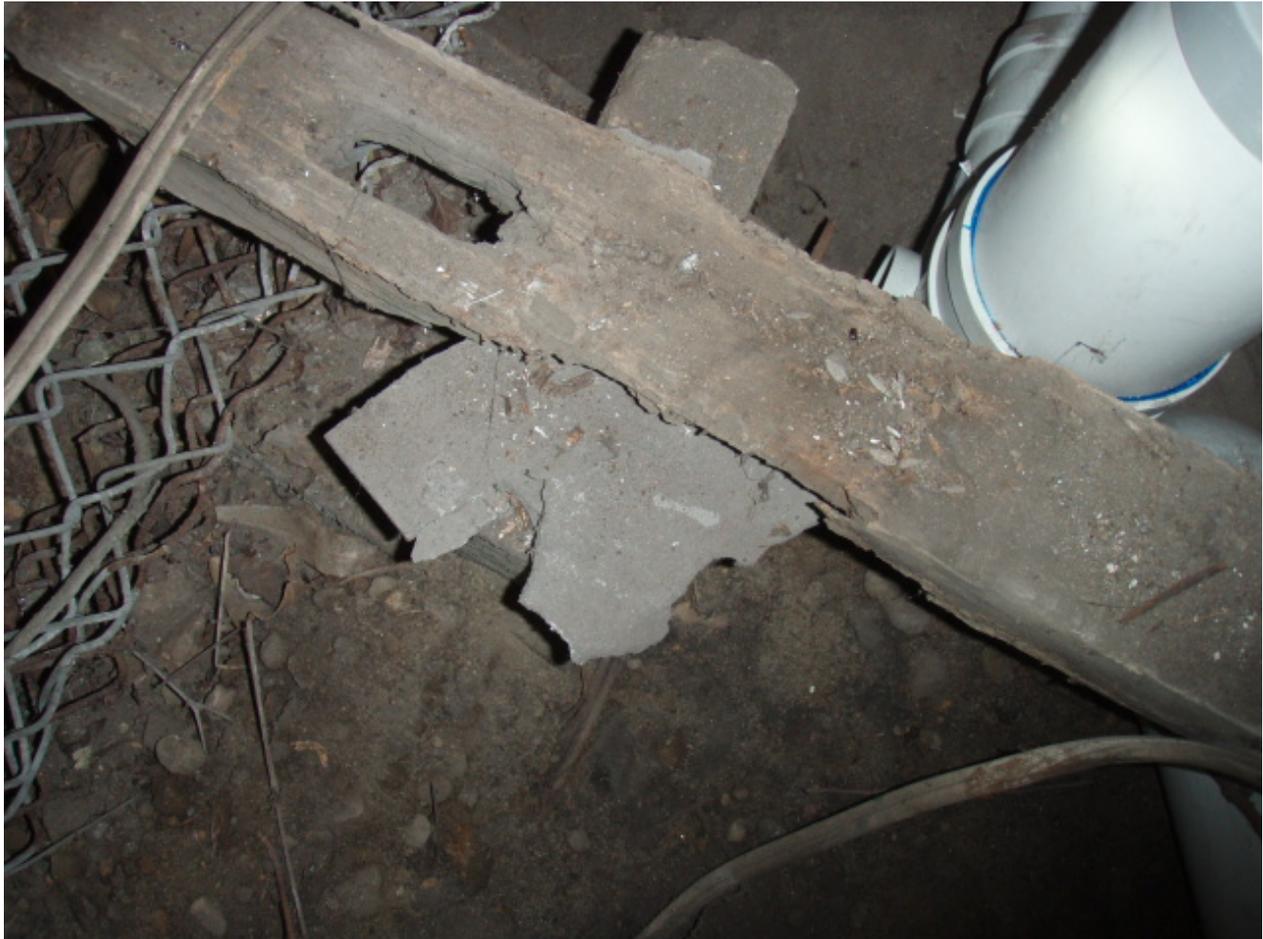
Photo 18: Fibre cement sheet packing (spacers) between the piers and bearers in the subfloor under the lounge room.

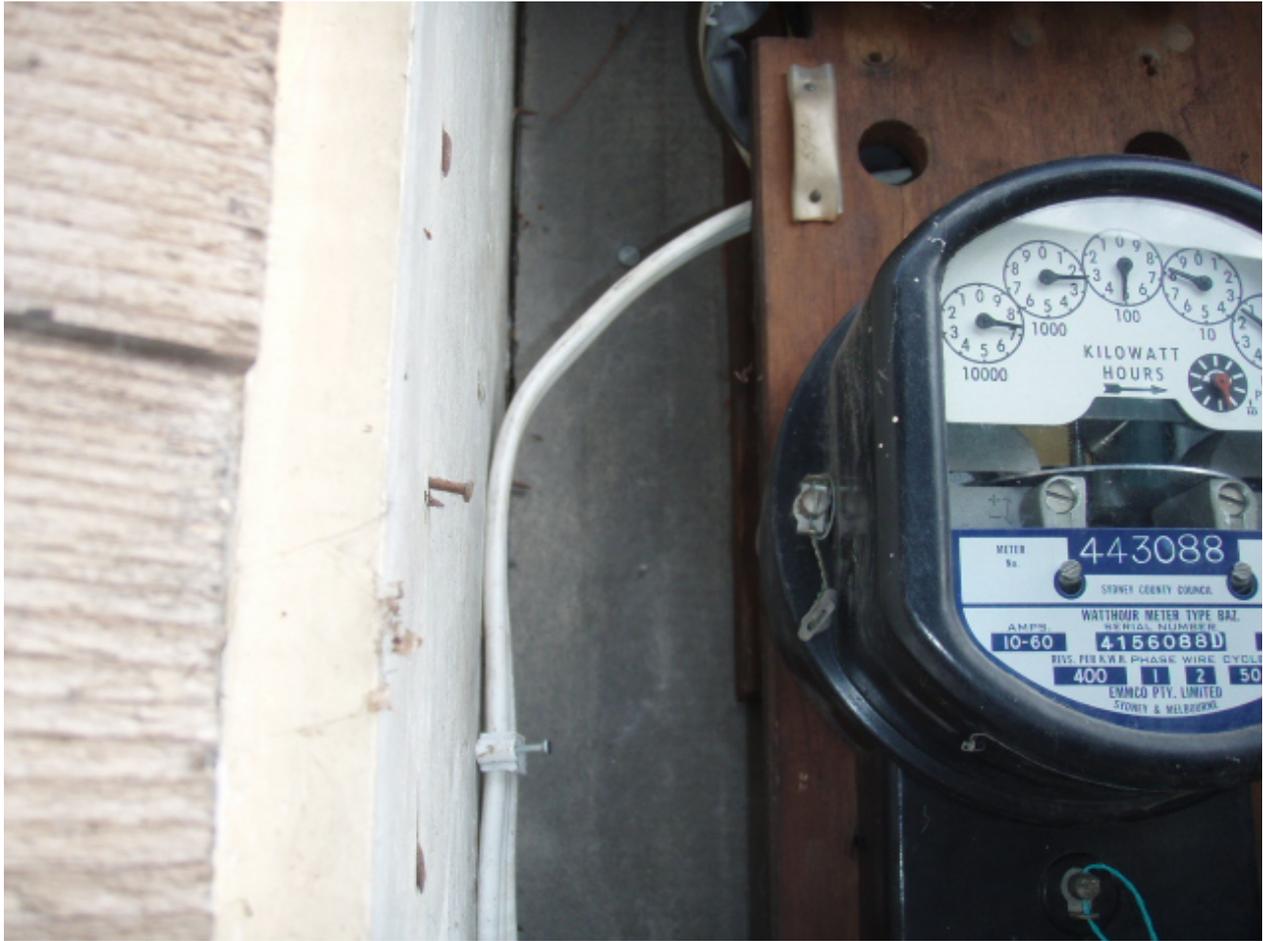
Location Item or Material Description Comments	Sample ID	Asbestos Type	Condition	Friability	Disturbance Potential / Accessibility	Risk Assessment Risk Rating	Quantity	Photo No.
Subfloor								
Fibre cement sheet packing (spacers) between the piers and bearers in the subfloor under the lounge room. Cracked and damaged.	Similar to Reference-1	Similar positive	Poor	Non friable	High	High	Less than 1m ²	18
Control Recommendation	Remove as soon as practicable. Avoid further mechanical damage and abrasion. Implement regular inspections, at least annually, or earlier if disturbed or removed.							
Electrical Meter Box								
Fibre cement sheeting to the rear wall in the electrical meter box. Cracked and damaged. It is likely that the dust and debris in the electrical meter box are contaminated with asbestos. This presents a significant risk of inhalation of airborne asbestos fibres to persons utilising the electrical meter box. The dust and debris in the electrical meter box should be presumed to contain asbestos and should be removed as soon as practicable. Restrict access to the electrical meter box.	Similar to Reference-1	Similar positive	Poor	Non friable	Low	Medium	1m ²	19

Photo 19: Fibre cement sheeting to the rear wall in the electrical meter box.

Control Recommendation	Remove or seal as soon as practicable. Avoid further mechanical damage and abrasion. Implement regular inspections, at least annually, or earlier if disturbed or removed.							
Hot Water System								
No asbestos-containing materials were evident to the hot water system.								
Carport								
No asbestos-containing materials were evident to the carport.								
Grounds								
Fibre cement sheeting on the ground to the right hand side of the building at the exterior of the bathroom. Cracked and damaged.	Similar to Reference-1	Similar positive	Poor	Non friable	High	High	Less than 1m ²	20
Control Recommendation	Remove as soon as practicable. Avoid further mechanical damage and abrasion. Implement regular inspections, at least annually, or earlier if disturbed or removed.

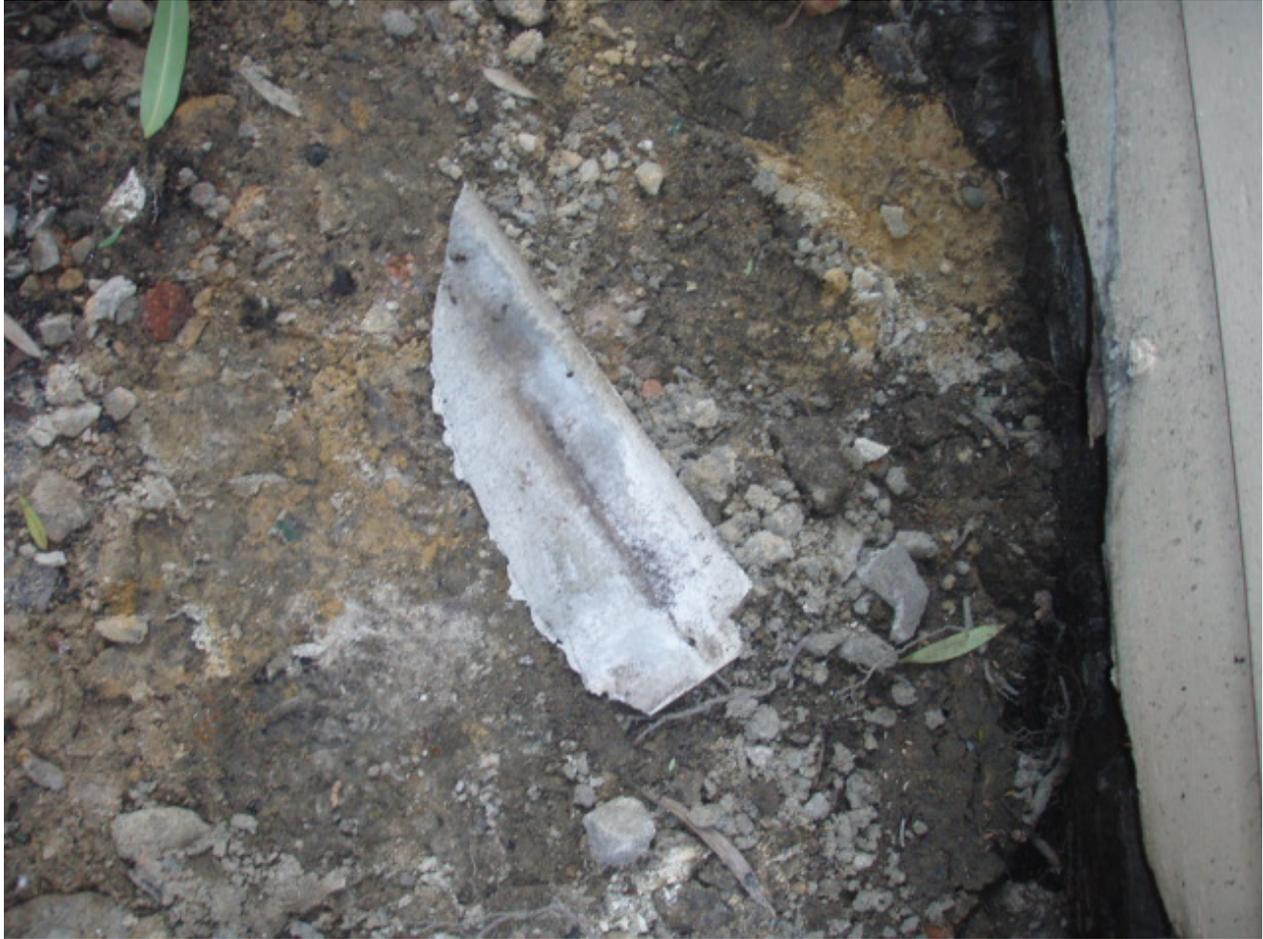
Photo 20: Fibre cement sheeting on the ground to the right hand side of the building at the exterior of the bathroom.
